The Alkali-Silica Reaction in Concrete

Edited by

R.N.SWAMY

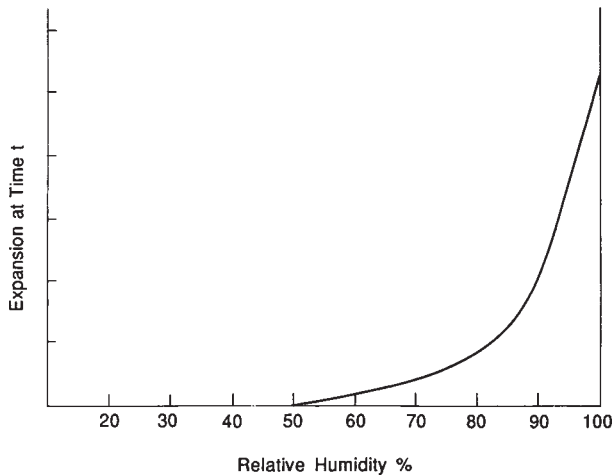
Figure 1.4 The effect of relative humidity on the expansion of concrete due to alkali-silica reaction.

Experiments and case study investigations have been able to demonstrate that the effects of alkali-silica reaction such as expansion vary directly with the percentage relative humidity of the concrete. The type of relationship is illustrated in [Figure 1.4](#). It can be seen that below 70% RH expansion and

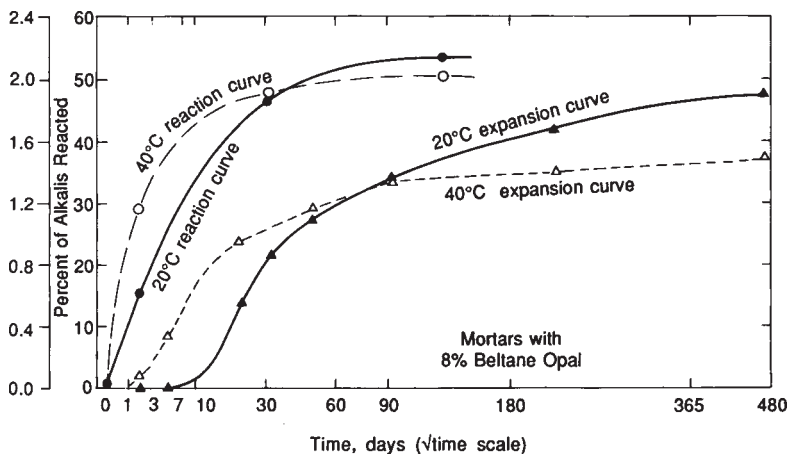
Figure 1.10 Comparison of reaction parameter curves versus expansion curves for sealed mortar specimens at 20°C and 40°C From Ref. 38.

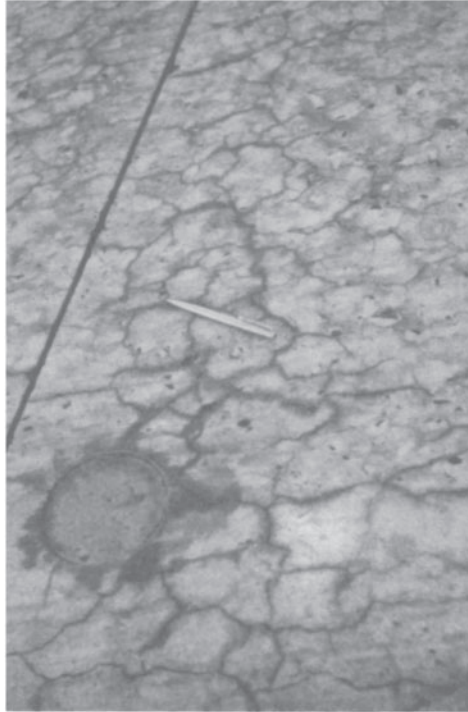
Figure 1.11 A portion of concrete road pavement, Cape Town. Length of the pencil is 125 mm.

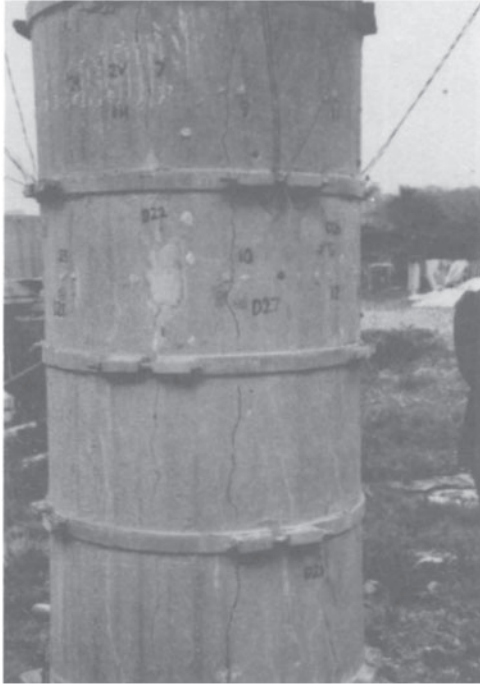
Figure 1.12 A section of a road bridge support column at the Mott MacDonald test exposure site, Devon.

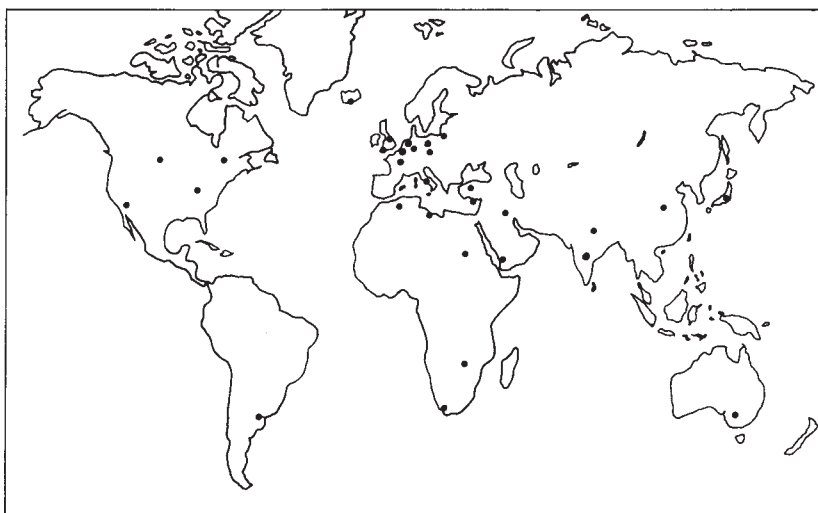
Figure 1.15 Recorded cases of alkali-silica reactivity.

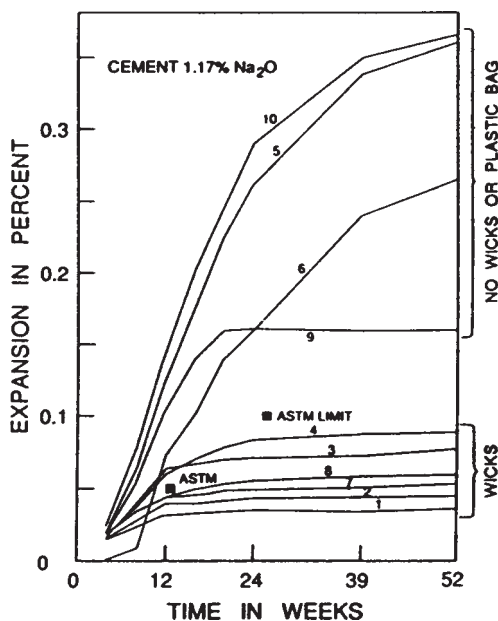
Figure 3.1 Influence of the presence or absence of wicks on mortar bar expansion tests. (Numbers refer to type of container.) From Ref. 17.

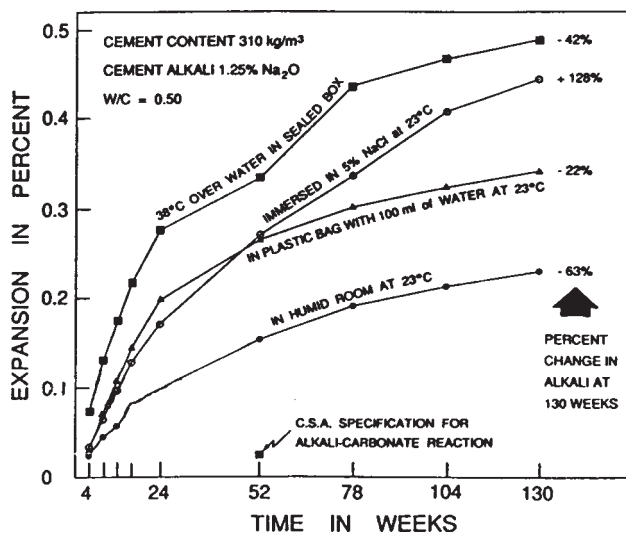
Figure 3.2 Interrelationship between concrete prism expansion, type of storage condition and water-soluble alkalis remaining in the concrete after 2½ years. From Ref. 17.

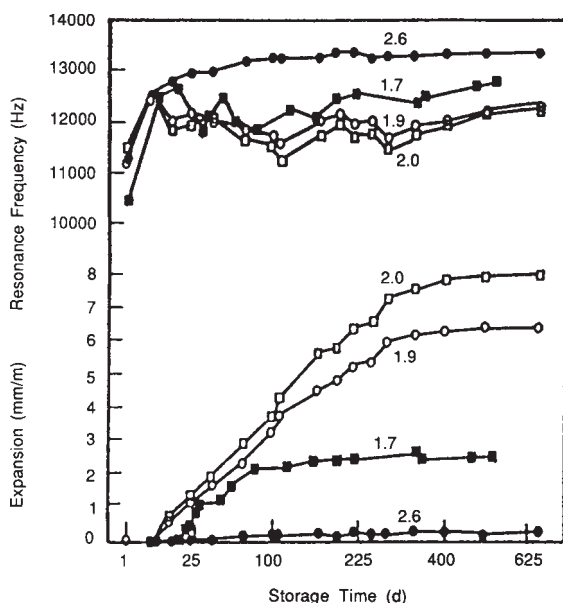
Figure 3.6 Effect of bulk density of opaline sandstone on ASR expansion and the resulting resonant frequency. From Ref. 49.

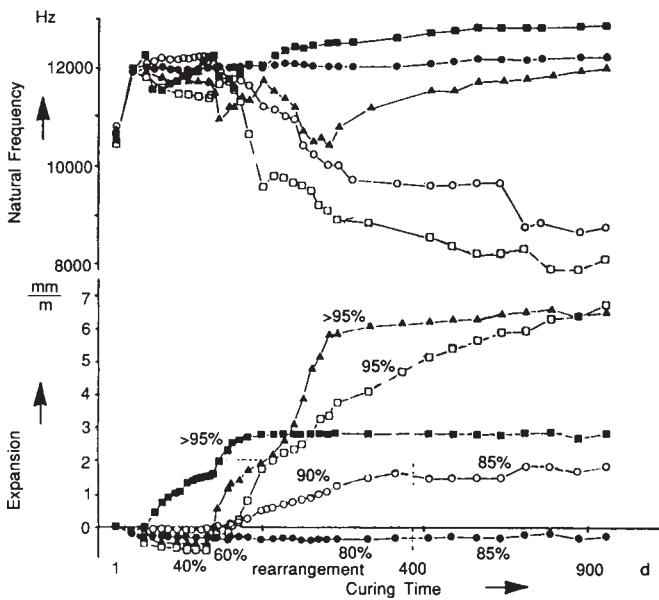
Figure 3.8 Effect of atmospheric humidity on ASR and resonant frequency. Conditions as for Figure 3.7. From Ref. 48.

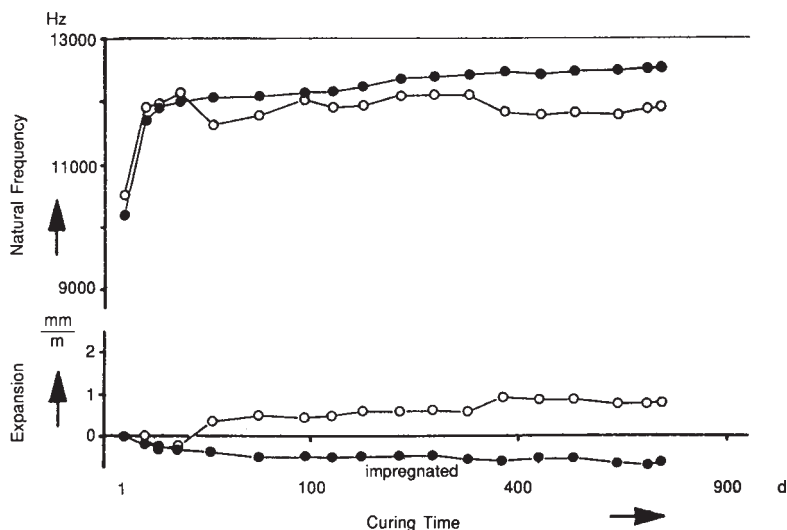
Figure 3.10 Effect of surface impregnation on ASR expansive strains and resonant frequency. Conditions as for Figure 3.7. From Ref. 48.

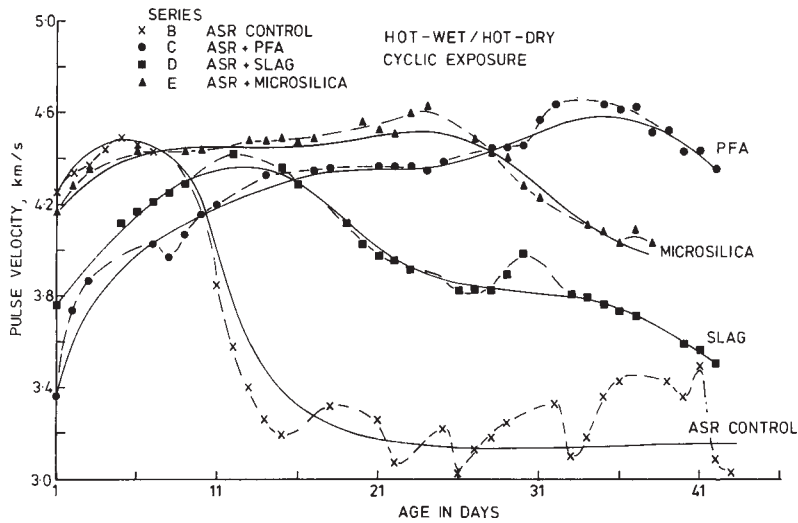
Figure 3.14 Variation of pulse velocity in ASR-affected concrete without and with mineral admixtures.

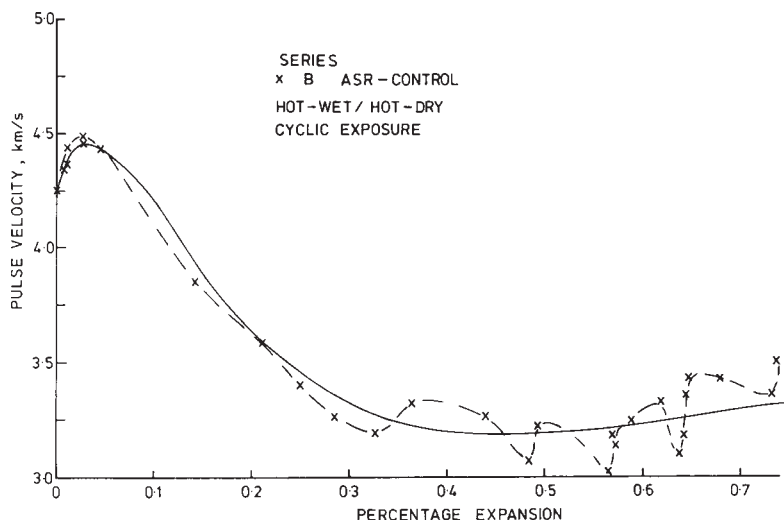
Figure 3.15 Variation of pulse velocity with expansion for ASR-affected concrete (series B).

The data presented in Figures 3.15 to 3.18 and Tables 3.11 and 3.12

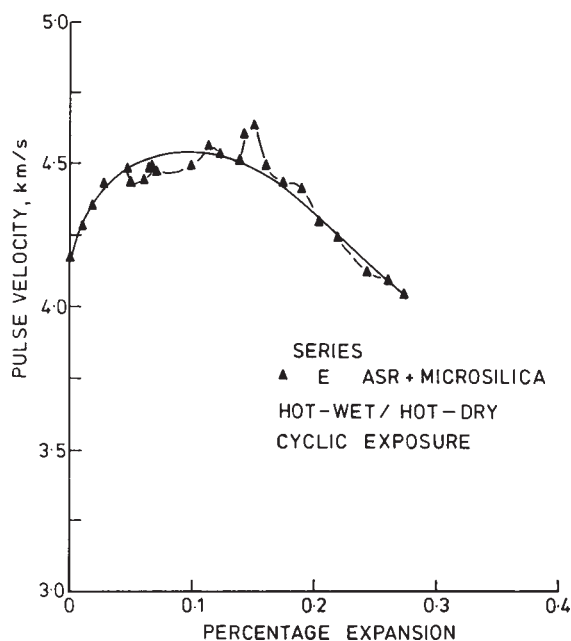
Figure 3.18 Variation of pulse velocity with expansion of ASR-affected concrete containing microsilica (series E).

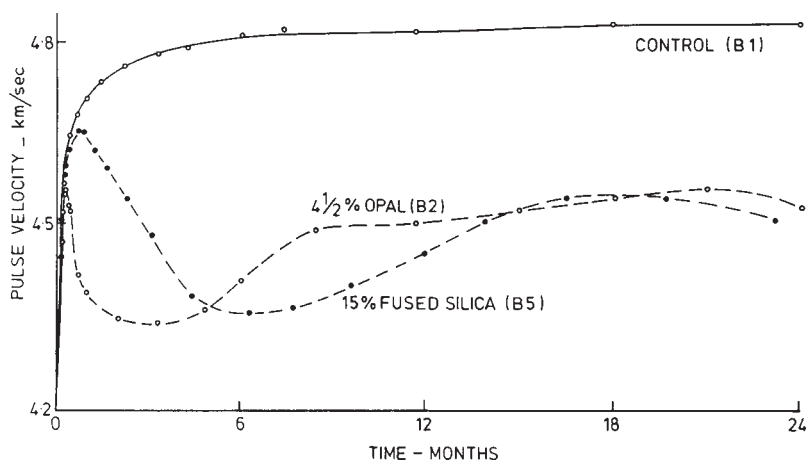
Figure 3.19 Longitudinal pulse velocity in ASR-affected reinforced concrete beams.

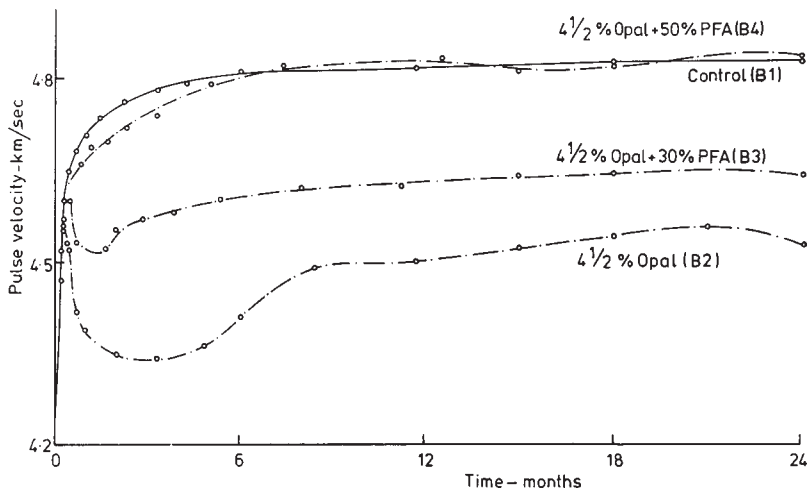
Figure 3.20 Effect of fly ash on pulse velocity values in ASR-affected beams containing opal reactive aggregate.

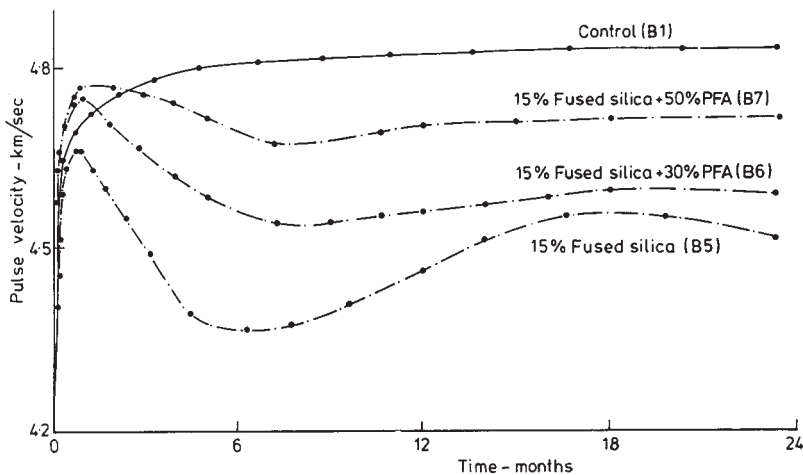
Figure 3.21 Influence of fly ash on pulse velocity variations in ASR-affected beams containing fused silica reactive aggregate.

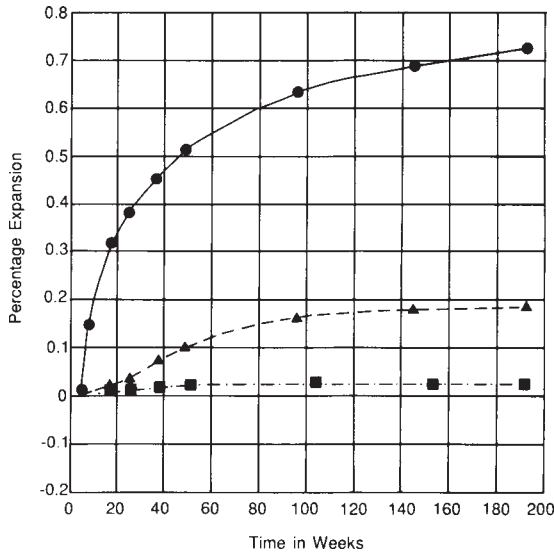
Figure 5.1 Comparison of mortar bar expansions for reactive American ‘control’ aggregates and Thames Valley flint sand: ■ Thames Valley sand; ▲ Nebraska sand; ● siliceous magnesian limestone 10% replacement in graded river sand. All results are for ‘medium’ alkali cement (0.7% Na₂O eq.), ‘low-quality’ mortar bars (higher water-cement ratios and greater porosities) stored at 20°C. Redrawn and adapted from Ref. 6.

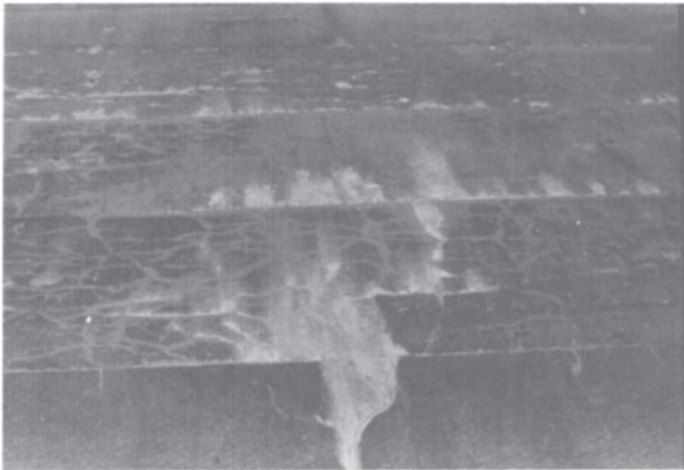
Figure 5.3 Part of the downstream face of the Val de la Mare Dam, Jersey, viewed from the parapet walkway, showing map cracking and exudations. From Ref. 52.

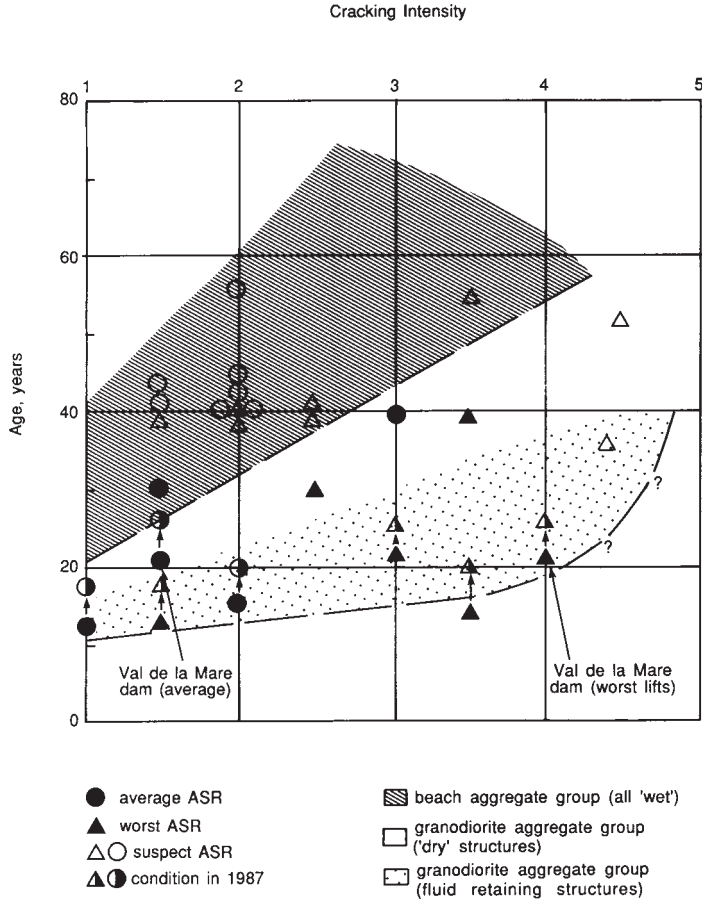
Figure 5.9 Survey of Jersey concretes (1982, updated 1987), showing that ASR damage is largely restricted to concretes made using granodiorite coarse aggregate and especially water-retaining structures. The 'cracking intensity' scale is defined by Ref. 59. From Ref. 9 after Ref. 59.

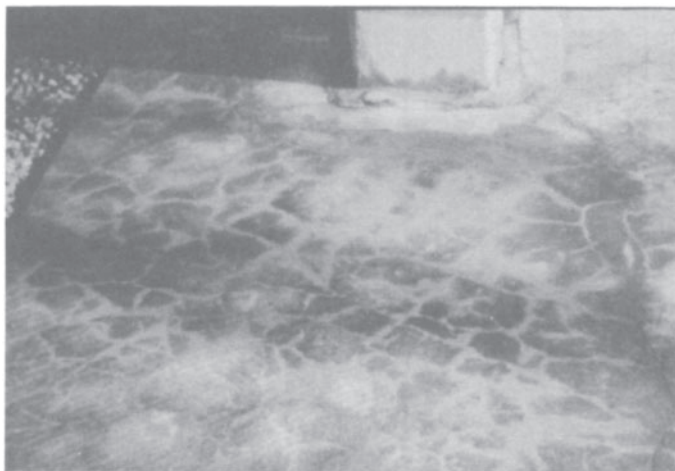
Figure 5.10 Concrete base at Milehouse electricity substation, Plymouth, showing map cracking.
From Ref. 11.

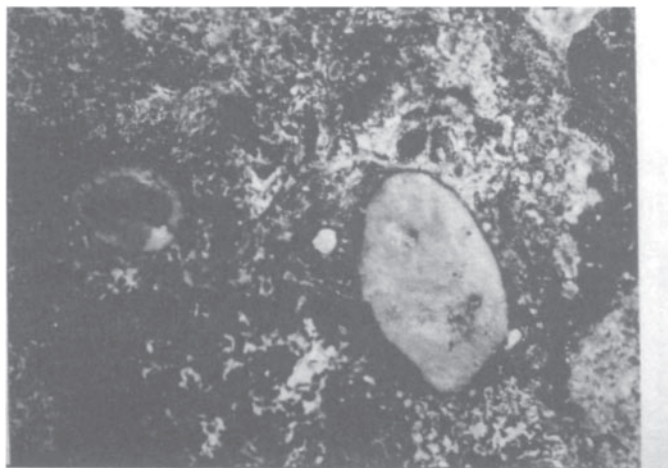
Figure 5.11 Detail of the concrete from a cracked base at Milehouse electricity substation, Plymouth, showing reactive chert particles. From Ref. 11.

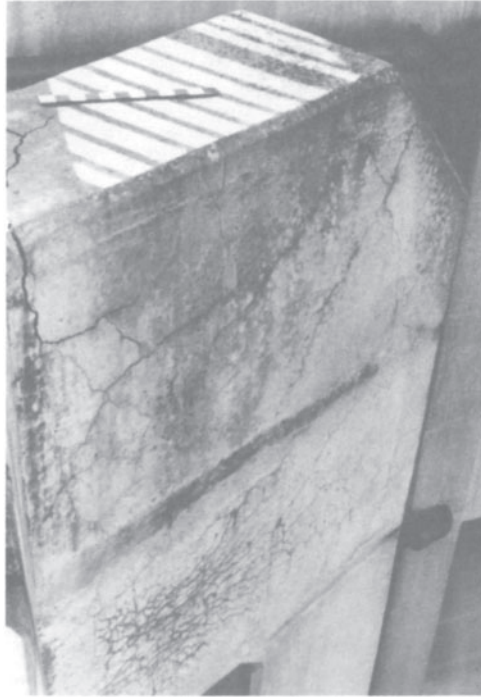
Figure 5.12 Charles Cross Car Park, Plymouth, showing a severely cracked column head.

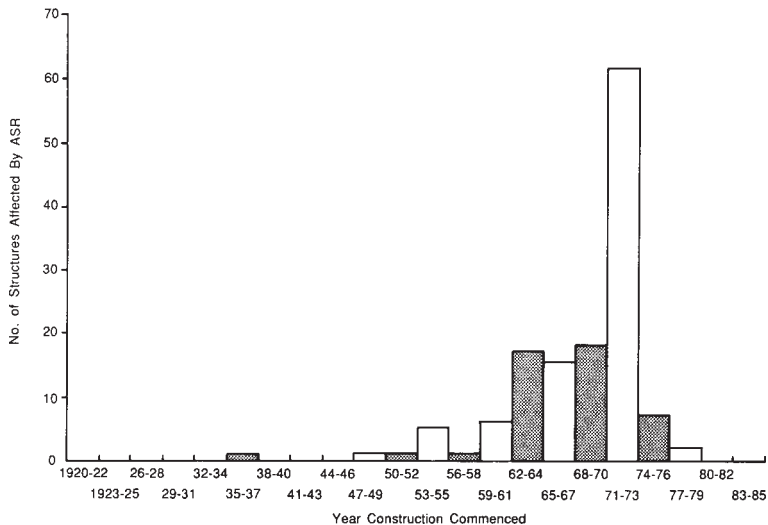
Figure 5.15 Diagram showing the frequency of the identified occurrence of ASR in construction of UK structures between 1920 and 1985. The histogram is *not* weighted to reflect the variations in intensity of construction. From Ref. 15.

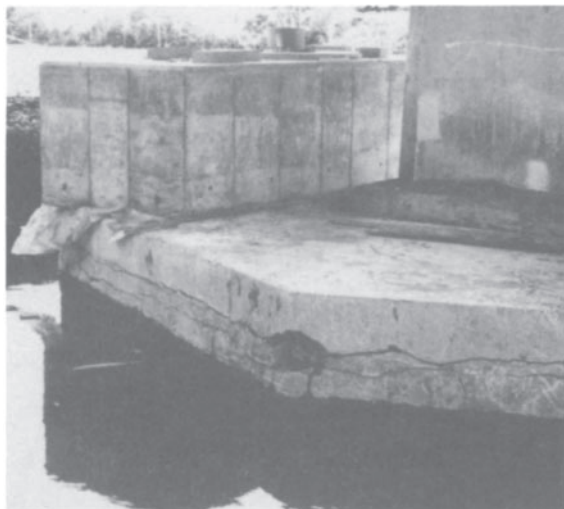
Figure 5.16 Marsh Mills Viaduct, near Plymouth, showing an excavation to reveal a severely cracked concrete pile cap, largely below the local water table.

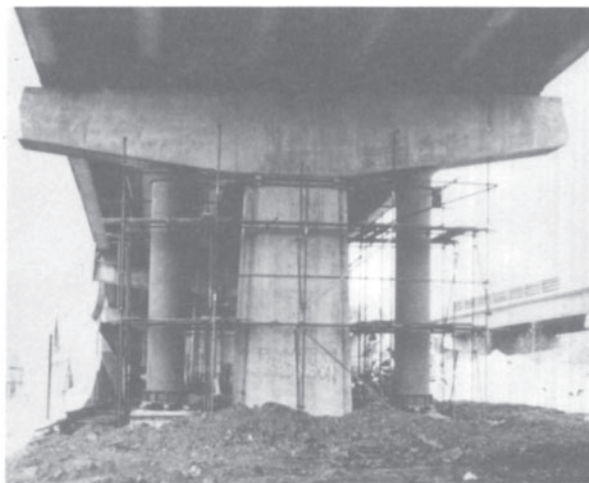
Figure 5.17 A pier of the Marsh Mills Viaduct, near Plymouth, showing the steel stanchions being installed as a measure to support the cantilever heads and modify load transference.

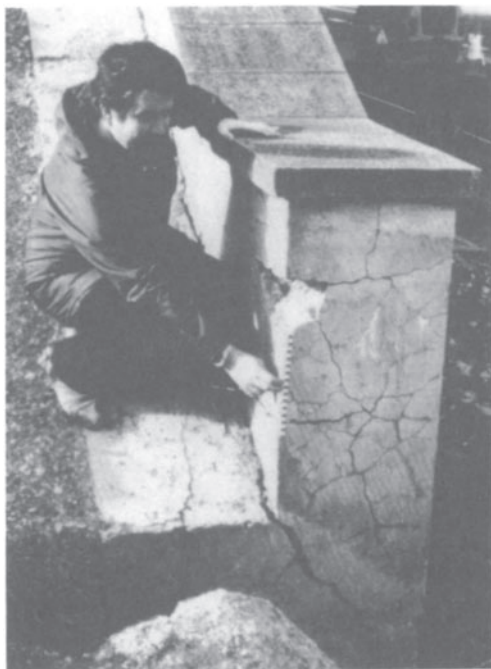
Figure 5.18 Voss Farm Overbridge, Devon, showing a severely cracked wing wall.

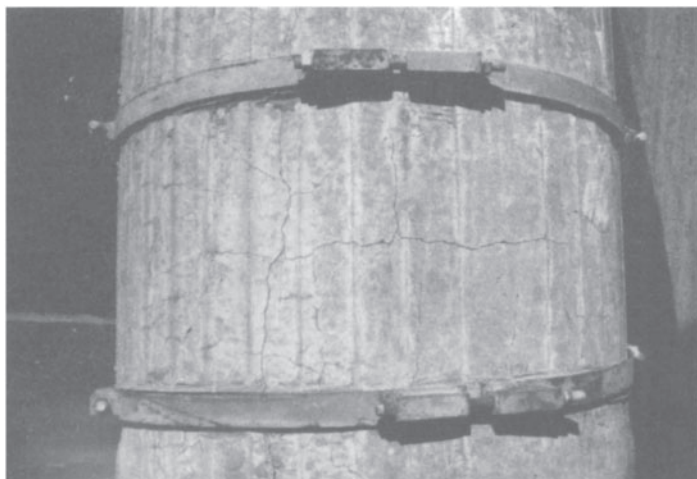
Figure 5.19 Voss Farm Overbridge, Devon, showing cracking in a heavily reinforced circular column (steel straps installed as temporary precaution). Photograph taken after removal of the column, showing the development of some horizontal cracking in addition to the dominant vertical cracking. Photograph by courtesy of G.V.Walters of ECC Quarries Limited, Exeter, Devon.

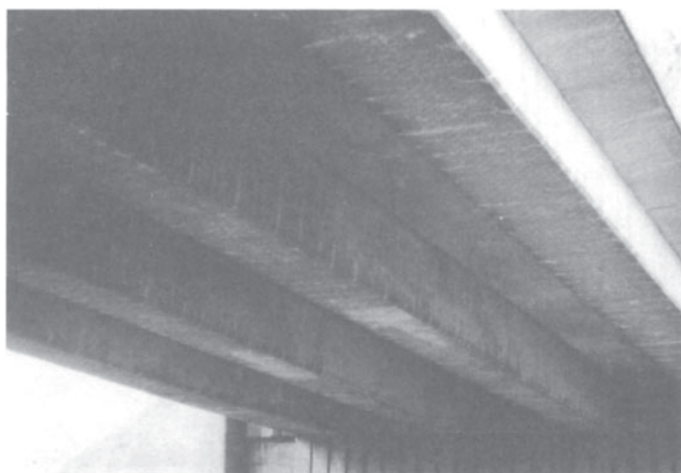
Figure 5.20 Smorrall Lane Overbridge, Warwickshire, showing regular tensile-style cracking of deck beams across the eastbound carriageway. From Ref. 71.

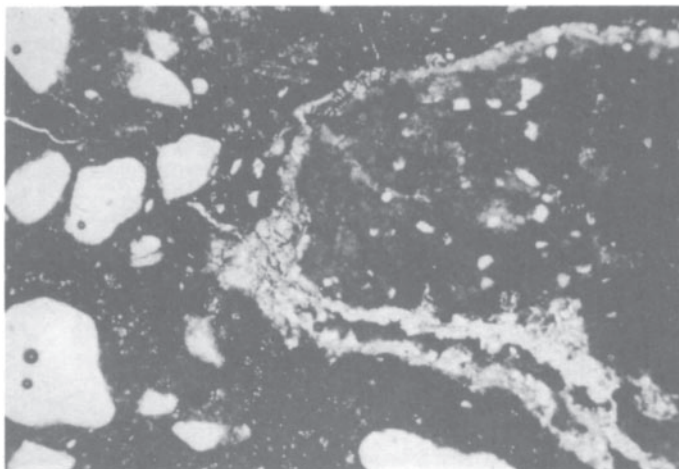
Figure 5.21 Photomicrograph of concrete from Smorrall Lane Overbridge deck slab, showing a reaction centre involving chert. Pln. Pols, (approx. $\times 15$ magnification). From Ref. 71.

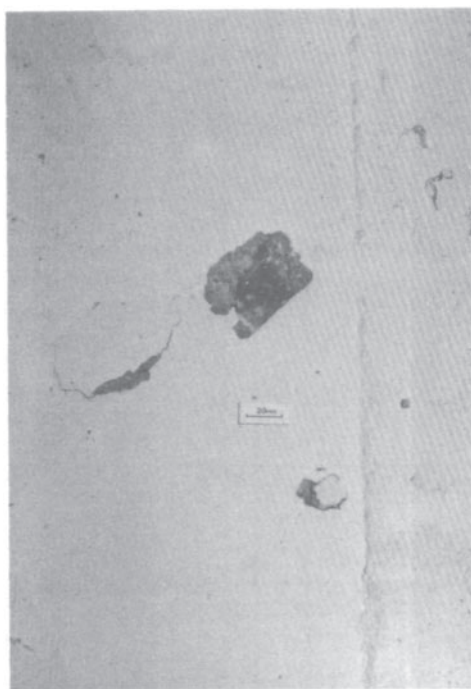
Figure 5.22 Unusual UK example of ASR in which surface gel exudations and pop-outs are the only detrimental features. Chert particles react in a surface zone which is greatly enriched in alkalis. From Ref. 77.

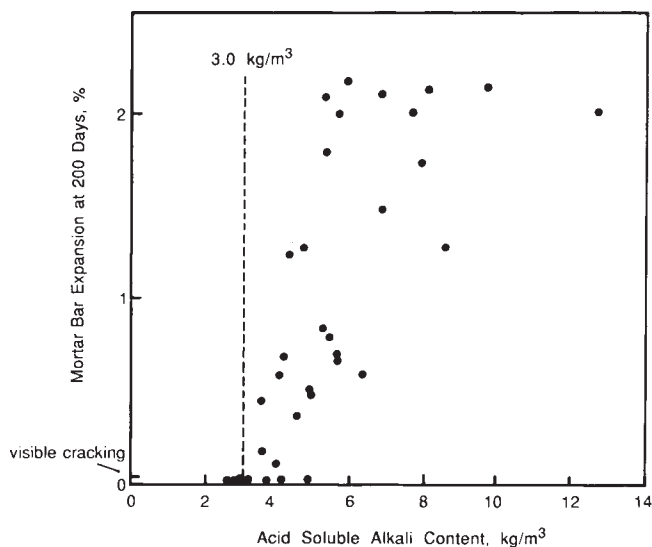
Figure 5.24 Relationship between the expansion of mortar bars at 20°C and the acid-soluble alkali content of the mortar, using opal as the reactive constituent, showing no expansion at alkali levels lower than 3.5 kg/m³. After Ref. 82.

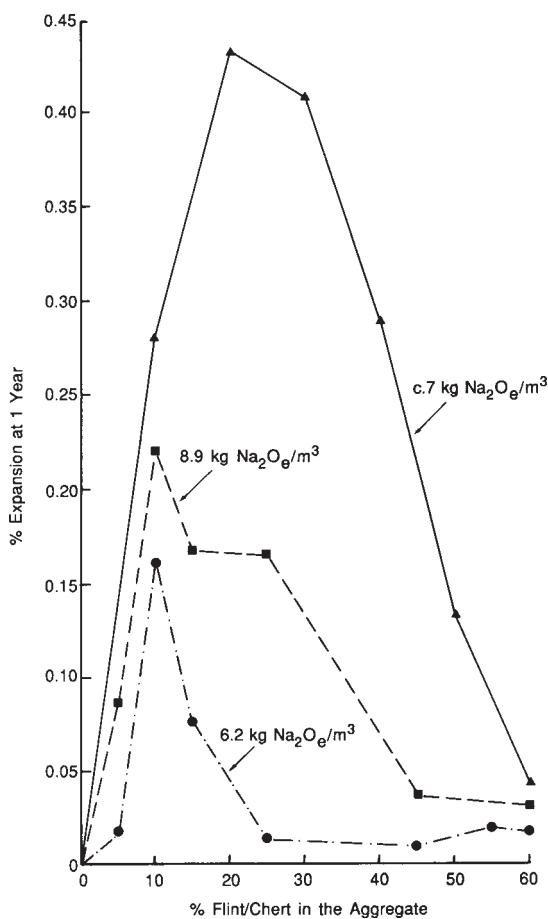
Figure 5.26 Some relationships between flint/chert content of aggregate and concrete prism expansion, indicating a flint/chert 'pessimum' of 10–30% for flint-limestone combinations and no significant expansions for mixtures containing more than 60% flint. Redrawn and adapted from Refs. 103 and 104.

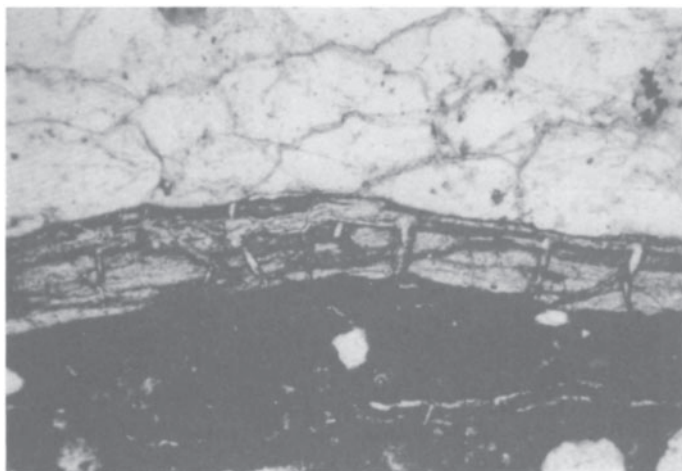
Figure 5.28 Photomicrograph of concrete showing desiccated alkali-silica gel infilling a microcrack peripheral to a quartzite coarse aggregate particle. Pln. Pols, (approx. $\times 35$ magnification). From Ref. 71.

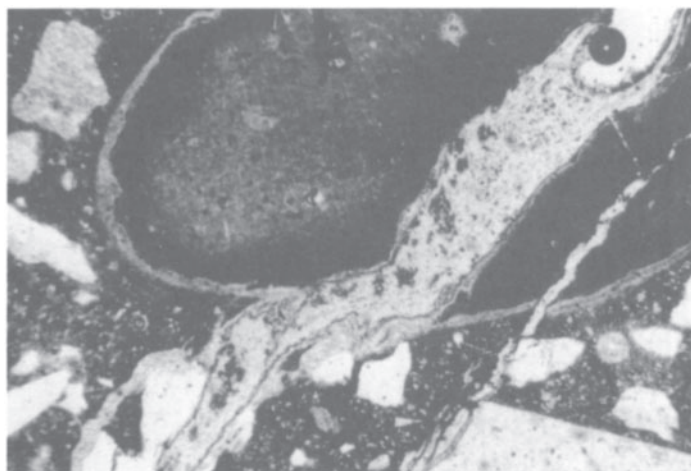
Figure 5.29 Photomicrograph of concrete showing a site of expansive reaction, involving a chert particle. Pln. Pols, (approx. $\times 45$ magnification).

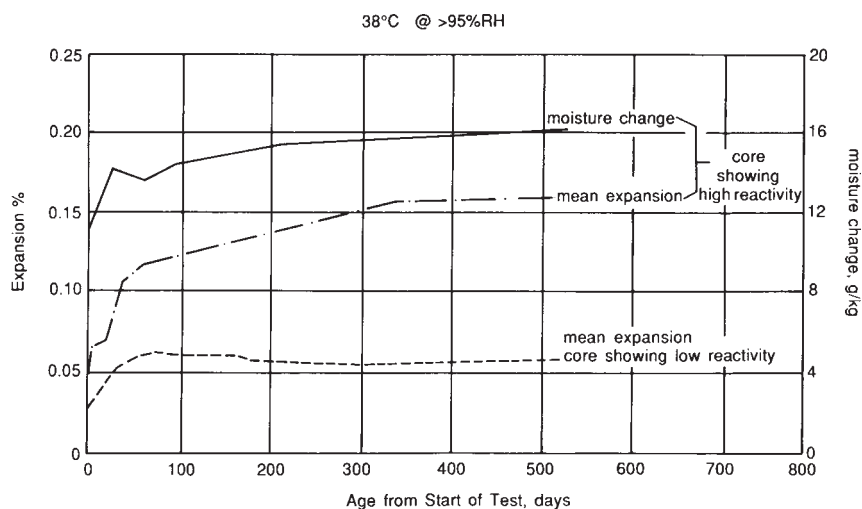
Figure 5.30 Typical levels of expansion recorded at 38°C in tests carried out on cores drilled from structures affected by ASR. Redrawn and adapted from Ref. 14.

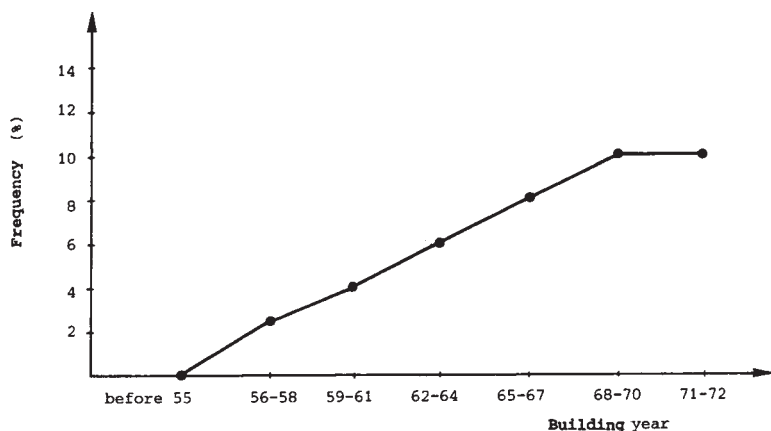
Figure 7.2 Cautious estimate of serious ASR damage in houses in Reykjavík and vicinity from a field survey in 1977–88. From Ref. 1.

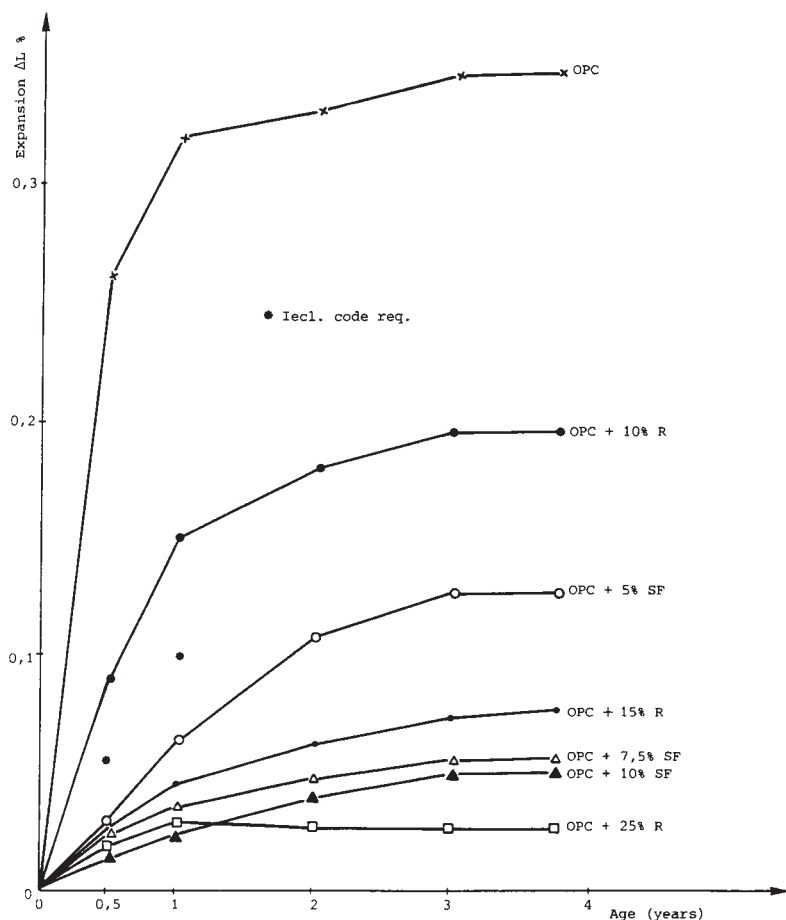
Figure 7.4 Rhyolite (R) and silica fume (SF) vs mortar bar expansion (Hvalfjörd sand).
From Ref. 7.

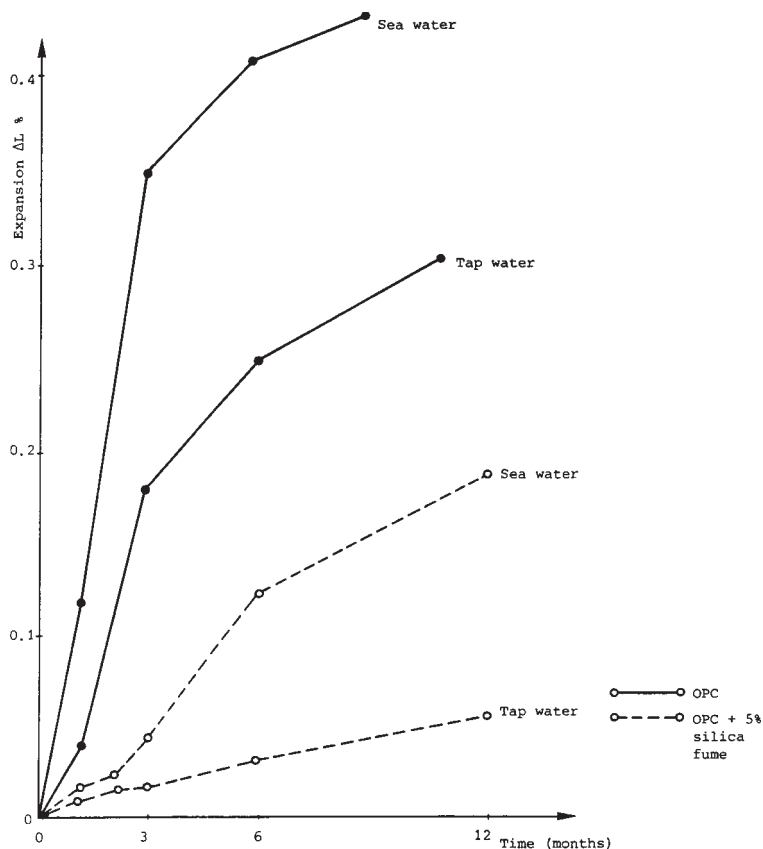
Figure 7.5 The influence of sea water on mortar bar expansion due to alkali-silica reactions (Hvalfjörð sand). From Ref. 7.

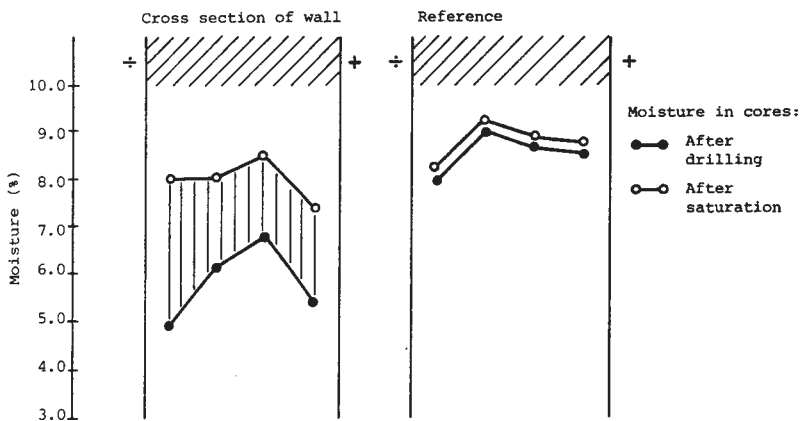
Figure 7.8 Moisture in the same wall as in [Figure 7.7](#) measured in drilled cores taken in August 1982. From Ref. 13.

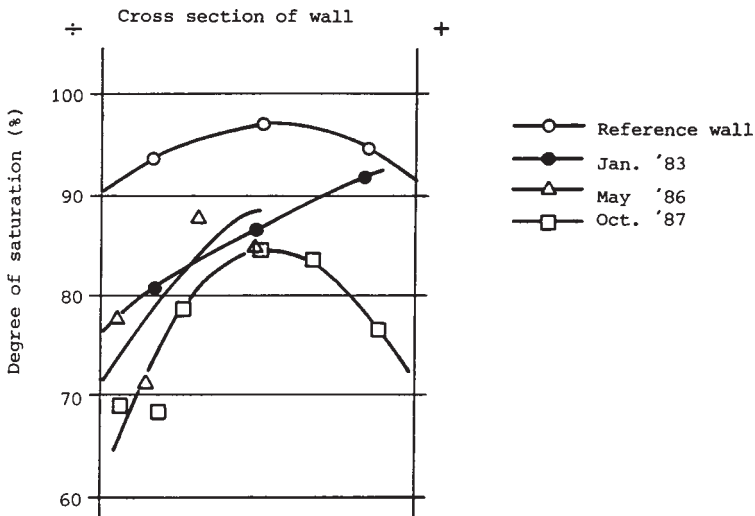
Figure 7.10 Moisture in the same wall as in Figure 7.9 measured in drilled cores taken at different times. From Ref. 14.

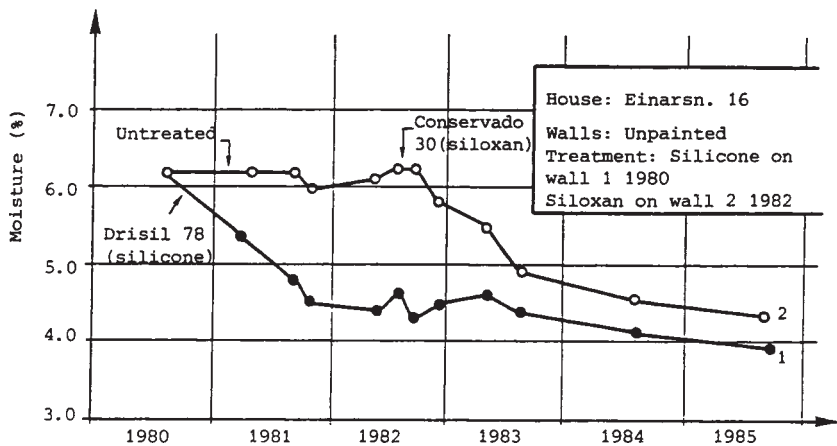
Figure 7.11 Moisture development in concrete after impregnation with silicone (Drisil 78) and siloxane (Conservado 30). From Ref. 15.

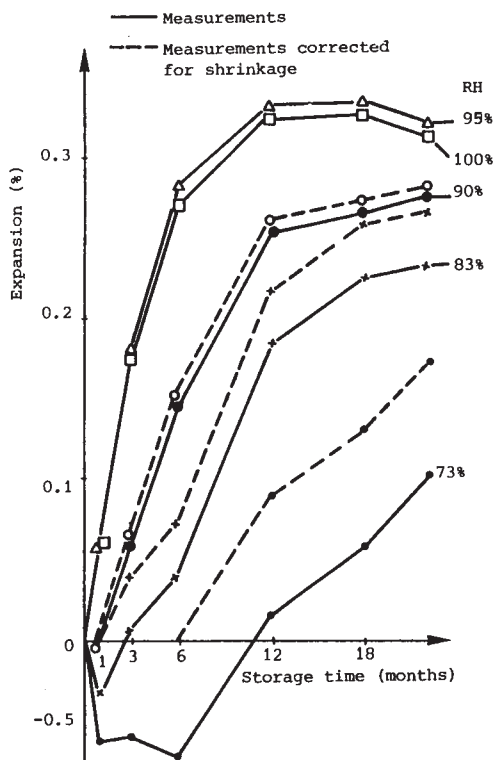
Figure 7.12 Expansion of mortar bars at temperature 38°C and RH 73–100%. From Ref. 16.

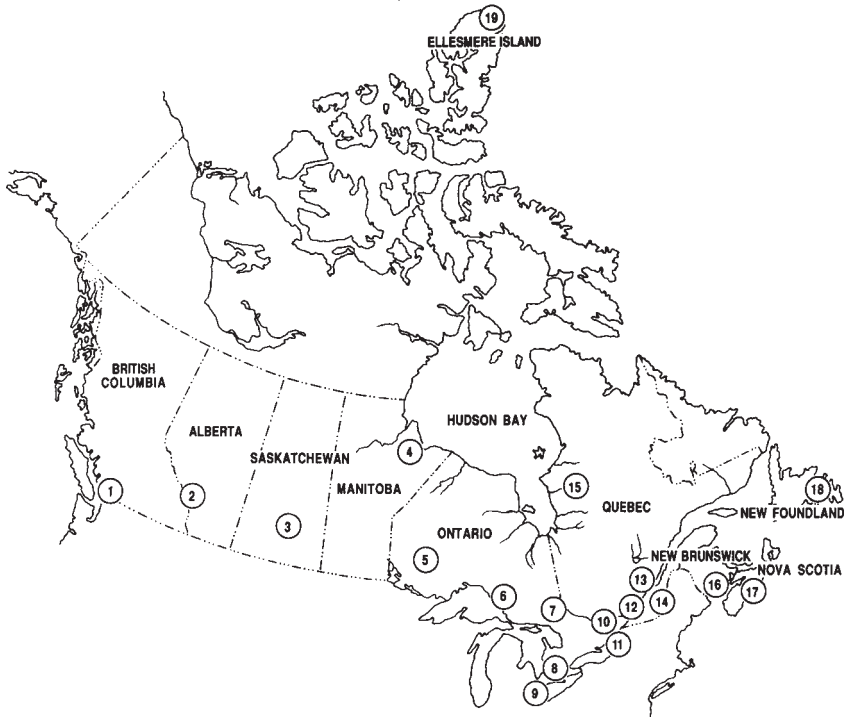
Figure 8.2 Map of Canada showing locations of sources of documented reactive aggregates. 1, *Chilliwack, BC*, acid volcanic rock in gravel deposits; 2, *Near Calgary, Alberta*, metaquartzite rock and chert; 3, *South Saskatchewan River, Saskatchewan*, opaline shale; 4, *Nelson River, Manitoba*, dolomitic limestone (alkali-carbonate reaction); 5, *Sioux Lookout, north-western Ontario*, chert in gravels; 6, *Wawa, Ontario*, silicified volcanic glass and tuff from gravel; 7, *Sudbury area of Ontario*, argillite, greywacke, quartz arenite and quartz sandstone from gravel deposits; 8, *south-western Ontario*, potentially reactive cherts; 9, *Windsor, Ontario*, chert in fine gravel; 10, *Ottawa area, Ontario*, silicious limestone; 11, *Kingston and Cornwall, Ontario*, alkali-carbonate reaction; 12, *Montreal area, Quebec*, sandstone and silicious limestone; 13, *Quebec City, Quebec*, silicious limestone; 14, *Beauceville region, Quebec*, andesitic tuff; 15, *James Bay region of Quebec*, biotite gneiss; 16, *southern New Brunswick*, gravel deposits containing quartz arenites, argillites, greywackes and volcanic rocks; 17, *Nova Scotia*, quartzites, greywackes, phyllites quartz arenites, argillites and rhyolite from several areas; 18, *eastern Newfoundland*, silicified volcanic rock in gravel deposits; 19, *Alert, Ellesmere Island*, greywacke and chert (silicified volcanics).

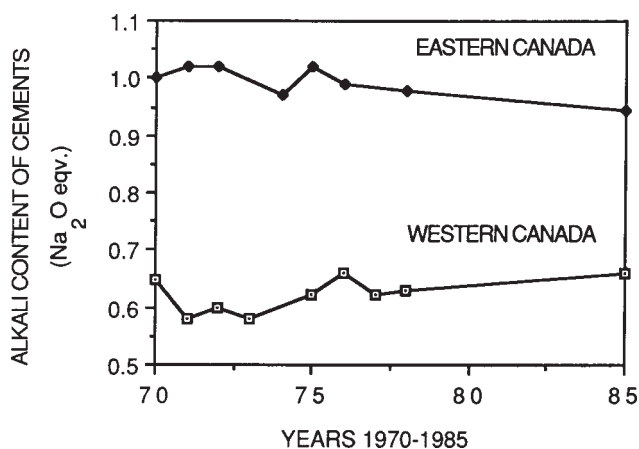
Figure 8.4 Variation in alkali levels in cements in eastern and western Canada from 1970 to 1985. Data from Canadian Portland Cement Association.

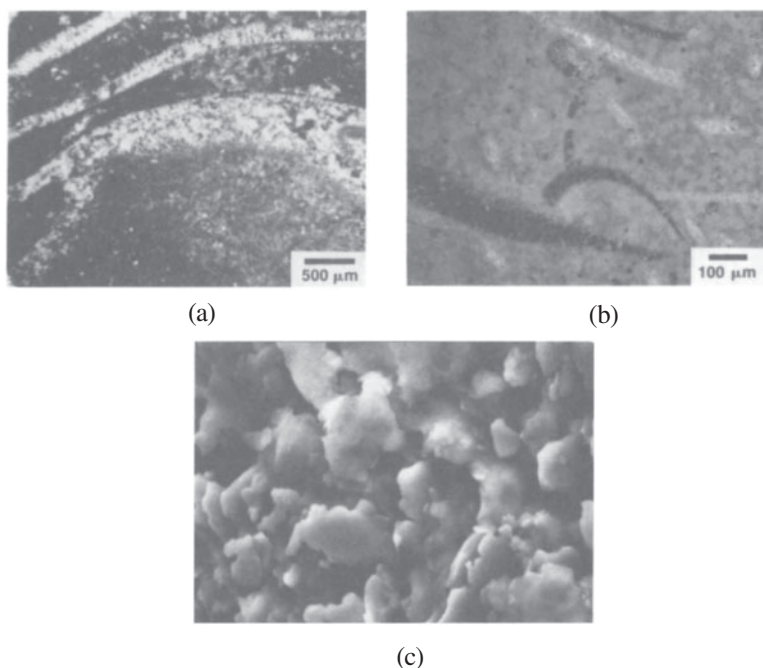
Figure 8.11 Micrographs of chert from northern Ontario, (a) Optical micrograph showing cryptocrystalline silica (C) and amorphous silica (A), (b) Optical micrograph of fine-grained chert derived from limestone, showing silicified bivalves (B) and sponge spicules (S). (c) SEM micrograph of chert illustrated in (b), showing that it is composed of irregularly shaped silica particles in about 5 μm grain size.

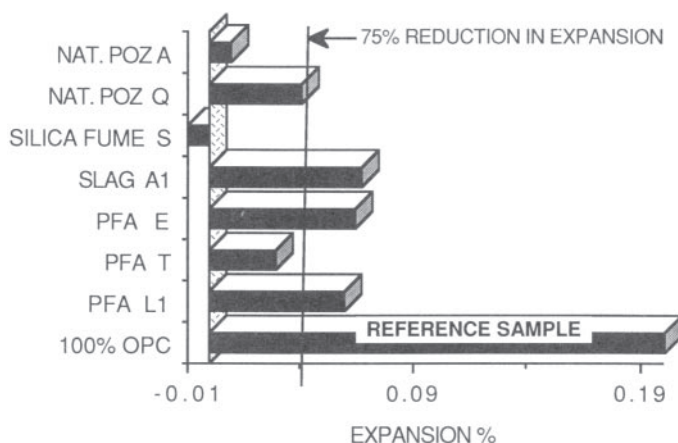
Figure 8.17 Effectiveness of a number of supplementary cementing materials in reducing expansion of mortar bars in ASTM test C441. Data from Ref. 50.

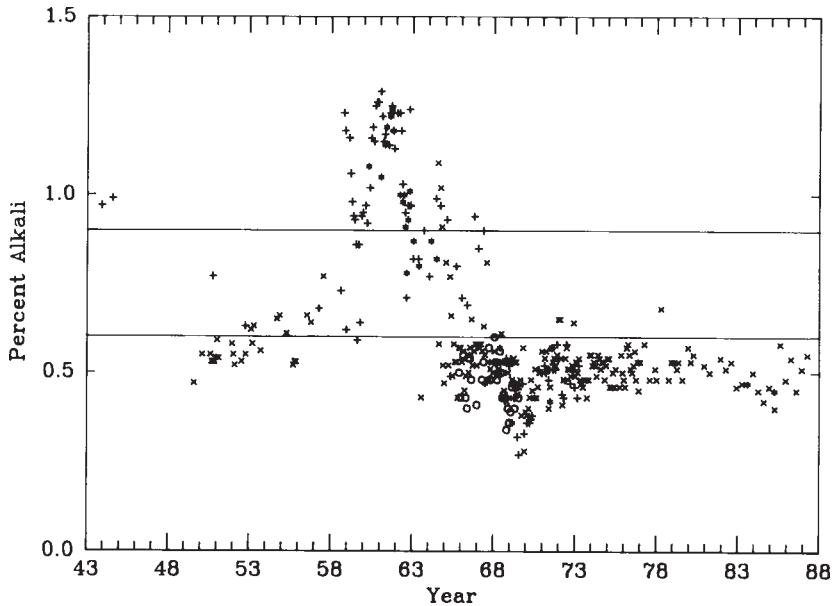
Figure 9.2 Results of available alkali analyses of the production from one of the original cement works for the period 1943–1988 showing the marked production of high-alkali cement between 1958 and 1968. +, ordinary; x, low-alkali; *, rapid-hardening; O, special. From Ref. 1.

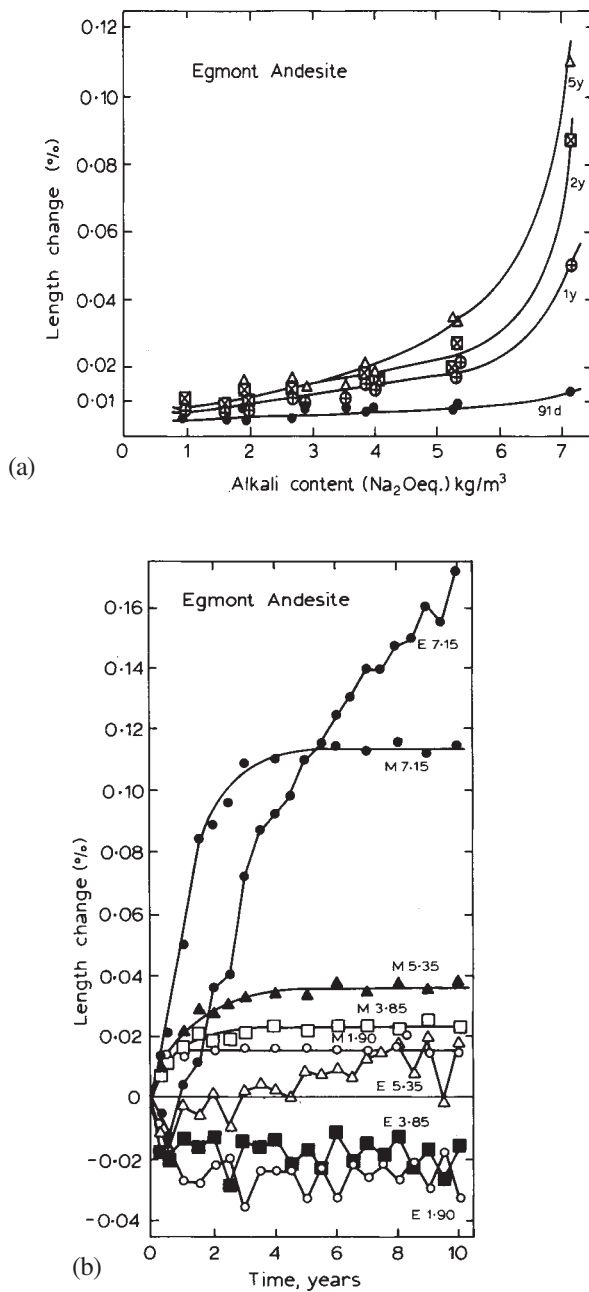
Figure 9.5 (a) The expansion of concrete prisms, moist-cured at 21°C, made from Egmont andesite versus the alkali content of the concrete, (b) The length change versus time for concretes with individual alkali contents (kg/m^3) and subjected to moist curing conditions (M) and to outdoor exposure (E). Cement content 600 kg/m^3 . From Ref. 11.

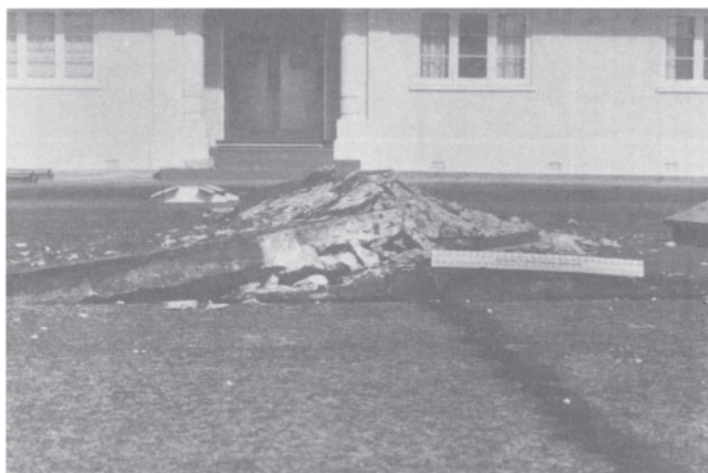
Figure 9.6 This spectacular case of damage occurred in an airbase pavement when 20 years after construction some new concrete was laid abutting one end. The results of restraining the expansion due to AAR were released rapidly during one night.

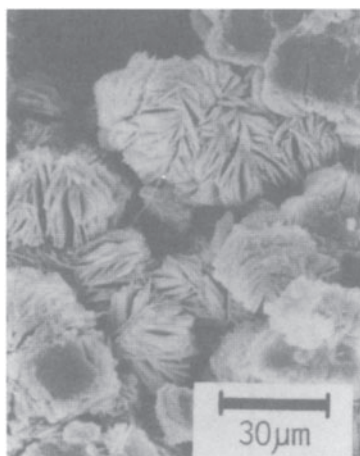
Figure 10.5 Scanning electron micrograph of rosette-like products. From Ref. 10.

reaction product was rosette-like (Figure 10.5). Such rosette-like reaction products were also found in other affected concrete (Figure 10.6). As shown in Figure 10.7, Morino *et al.* found a reaction product among the interstices of microcrystalline quartz crystals in the cherty rock contained in the concrete cores drilled from a 10-year-old concrete structure¹¹.

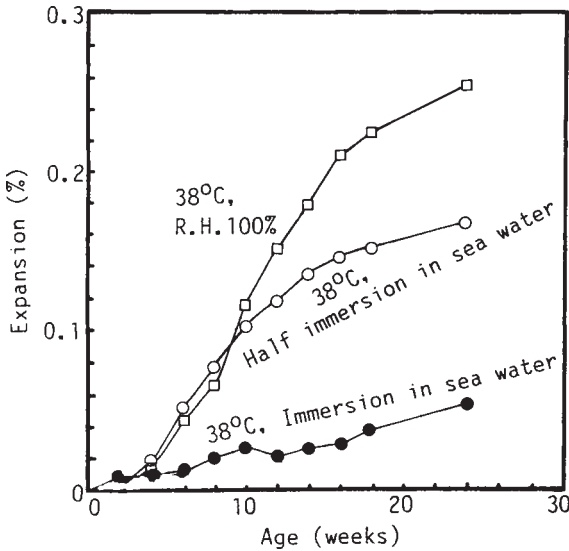
Figure 10.15 Influence of seawater on the expansion of concrete (concrete made with 500 kg/m³ ordinary Portland cement and reactive andesite coarse aggregate).

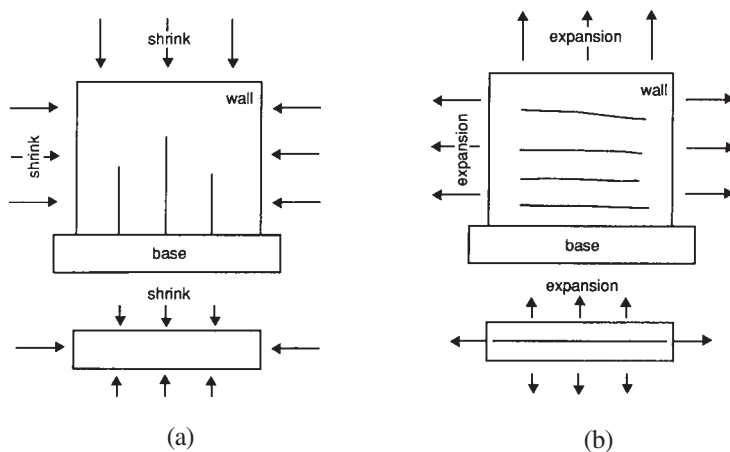
Figure 10.16 Cracking pattern in a reinforced concrete wall, (a) Cracking due to temperature drop or drying shrinkage, (b) Cracking due to ASR.
