The Alkali-Silica Reaction in Concrete

Edited by

R.N.SWAMY

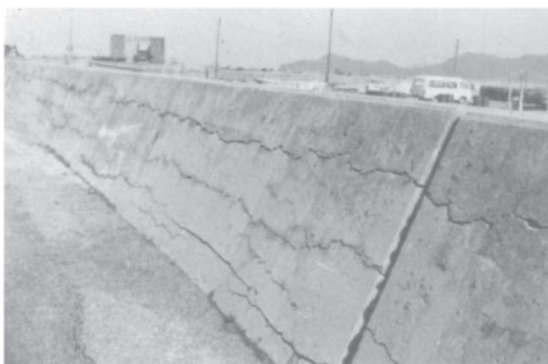
Type of structure	Retaining wall
Year of construction	NI
Reactive aggregate	Chert, slate
Compressive strength of core	NI
Corrosion of reinforcing bar	NI
Crack width	10mm
depth	NI
Ambient condition	Unsheltered at the seaside
NI: Not investigated

Figure 10.21 Cracking in a retaining wall.

Figure 10.21 shows cracking in a retaining wall at the seaside, where horizontal cracking is again dominant. A typical case of cracking in a staircase is shown in Figure 10.22 where the axial cracking is again dominant. An example of cracking at the top of a wall type of structure is illustrated in Figure 10.23.

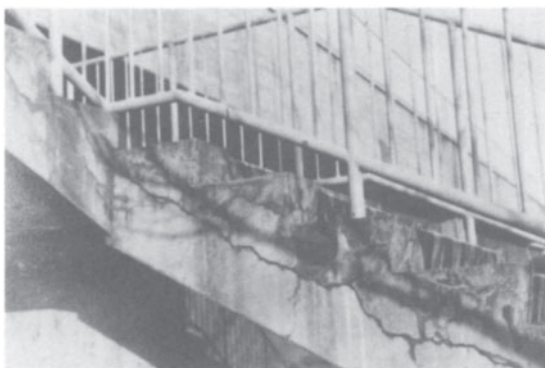
Type of structure	Staircase
Year of construction	NI
Reactive aggregate	Bronzite andesite
Compressive strength of core	NI
Corrosion of reinforcing bar	NI
Crack width	5–7mm
depth	NI
Ambient condition	Unsheltered
NI: Not investigated

Figure 10.22 Cracking in a staircase.

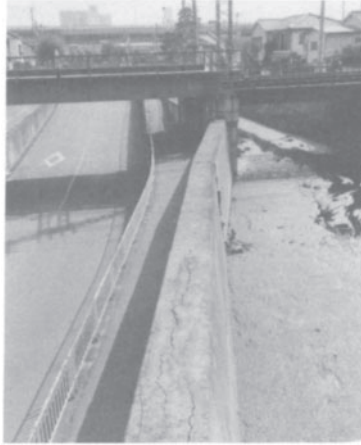
Type of structure	River defence
Year of construction	1971
Reactive aggregate	Bronzite andesite
Compressive strength of core	NI
Corrosion of reinforcing bar	NI
Crack width	10–15 mm
depth	NI
Ambient condition	Unsheltered
NI: Not investigated

Figure 10.23 Cracking in a river defence.

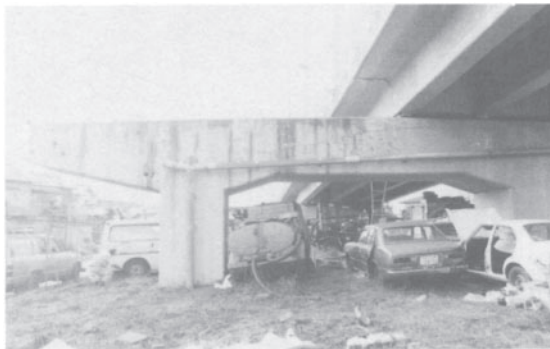
Type of structure	Pier
Year of construction	1969–1970
Reactive aggregate	Tuff
Compressive strength of core	NI
Corrosion of reinforcing bar	No corrosion
Crack width	0.1 mm
depth	3 cm
Ambient condition	Unsheltered
NI: Not investigated

Figure 10.24 Cracking in a pier—2.

Figure 10.24 shows an example of the effect of temperature or water on ASR. More cracks were found to be developing on the left-hand side of the pier than on the right-hand side, which was partially sheltered by the superstructure.

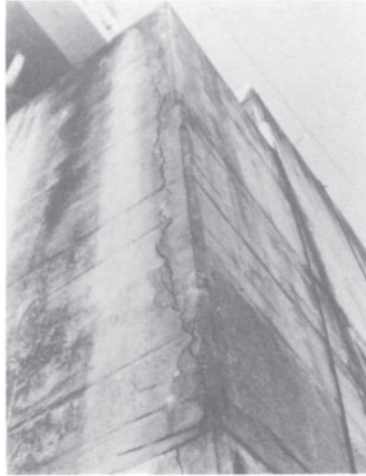
Type of structure	Abutment
Year of construction	1973–1975
Reactive aggregate	Chert, slate
Compressive strength of core	270 kgf/cm ²
Corrosion of reinforcing bar	Partially
Crack width	3 mm
depth	12cm
Ambient condition	Unsheltered at the seaside
NI: Not investigated

Figure 10.27 Cracking at the corner of an abutment.

Figures 10.25 and 10.26 are examples of irregular cracking occurring at the free end of structures, where restraint by the reinforcing bar is relatively weak. Cracks in Figure 10.27 are developing at the corner of the abutment, where restraint by reinforcing bar is also weak. Figures 10.28 and 10.29 are examples of irregular cracking in concrete with less reinforcement or without reinforcement.

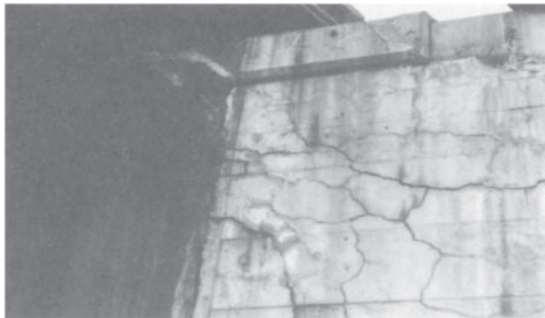
Type of structure	Wing of abutment
Year of construction	NI
Reactive aggregate	NI
Compressive strength of core	NI
Corrosion of reinforcing bar	NI
Crack width	5–10 mm
depth	NI
Ambient condition	Unsheltered
NI: Not investigated

Figure 10.28 Cracking in the wing of an abutment.

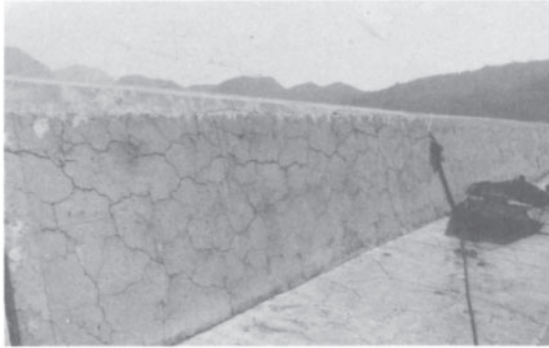
Type of structure	Sea defence (plain concrete)
Year of construction	NI
Reactive aggregate	Chert, slate
Compressive strength of core	140 kgf/cm ²
Corrosion of reinforcing bar	
Crack width	8–12 mm
depth	33 cm
Ambient condition	Unsheltered at the seaside
NI: Not investigated

Figure 10.29 Cracking in a sea defence wall of plain concrete.

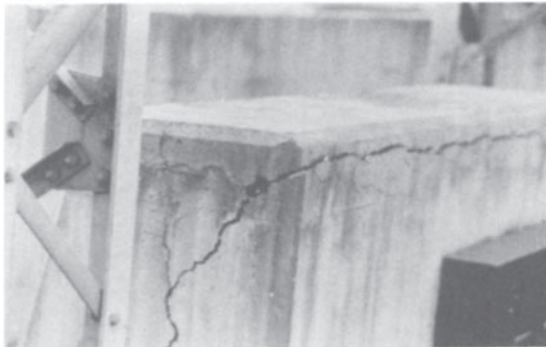
Type of structure	Stopper (plain concrete)
Year of construction	NI
Reactive aggregate	Bronzite andesite
Compressive strength of core	NI
Corrosion of reinforcing bar	
Crack width	10 mm
depth	NI
Ambient condition	Unsheltered
NI: Not investigated

Figure 10.30 Cracking in a stopper of plain concrete.

Figures 10.30 and 10.31 are examples of cracking in plain concrete. In these examples, fewer but wider cracks are developing.

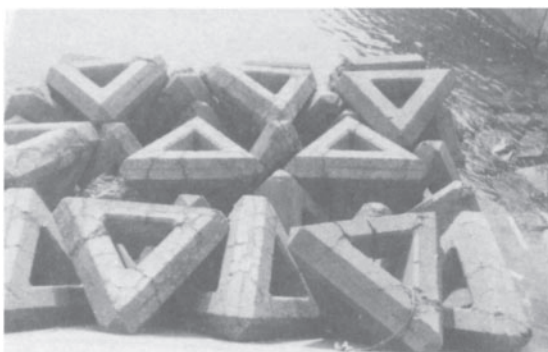
Type of structure	Precast concrete block (plain concrete)
Year of construction	1969–1970
Reactive aggregate	Chert, slate
Compressive strength of core	220 kgf/cm ²
Corrosion of reinforcing bar	
Crack width	10–15 mm
depth	NI
Ambient condition	Unsheltered in the sea
NI: Not investigated

Figure 10.31 Cracking in a precast concrete block.

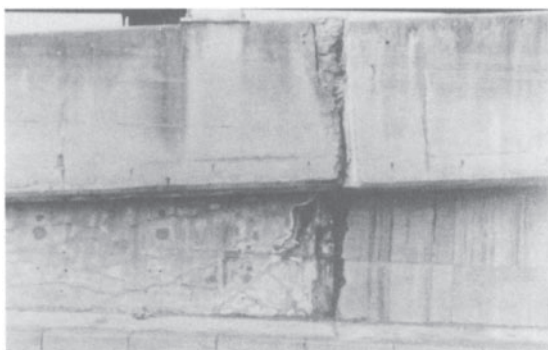
Type of structure	Retaining wall
Year of construction	NI
Reactive aggregate	Bronzite andesite
Compressive strength of core	175 kgf/cm ²
Corrosion of reinforcing bar	NI
Crack width	4mm
depth	14 cm
Ambient condition	Unsheltered
NI: Not investigated

Figure 10.32 Deformation and cracking of a retaining wall.

Figure 10.32 is an example of deformations arising from ASR. The retaining wall on the left-hand side is pushing up the adjacent retaining wall and causing damage at the joint.

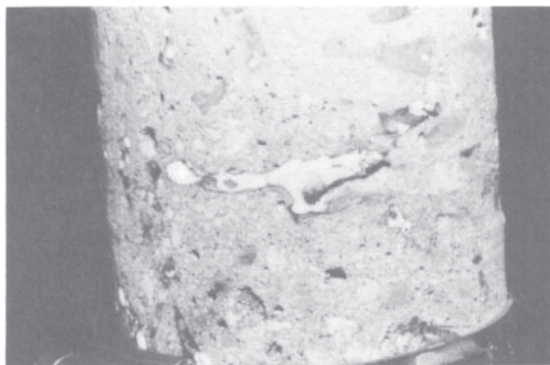
Figure 10.34 Exuded gel on the surface of a core.

The reactive aggregates identified as causing distress in the structures shown in Figures 10.17 to 10.32 are bronzite andesite, chert and slate. Bronzite andesite is the most widely occurring reactive aggregate in Japan. Figures 10.33 and 10.34 show the reaction rim and exuded gel of bronzite andesite at the cut surface of a drilled core.

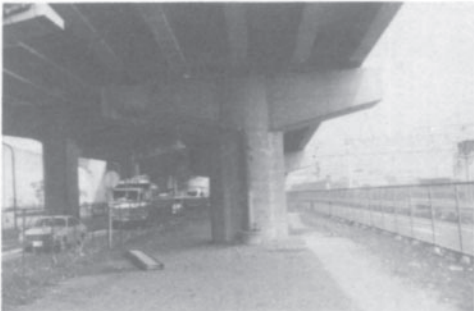
<p>Cracking pattern</p>

No. 1983-02	Type of structure	Pier	Construction	1977
			Ambient condition	Partially sheltered

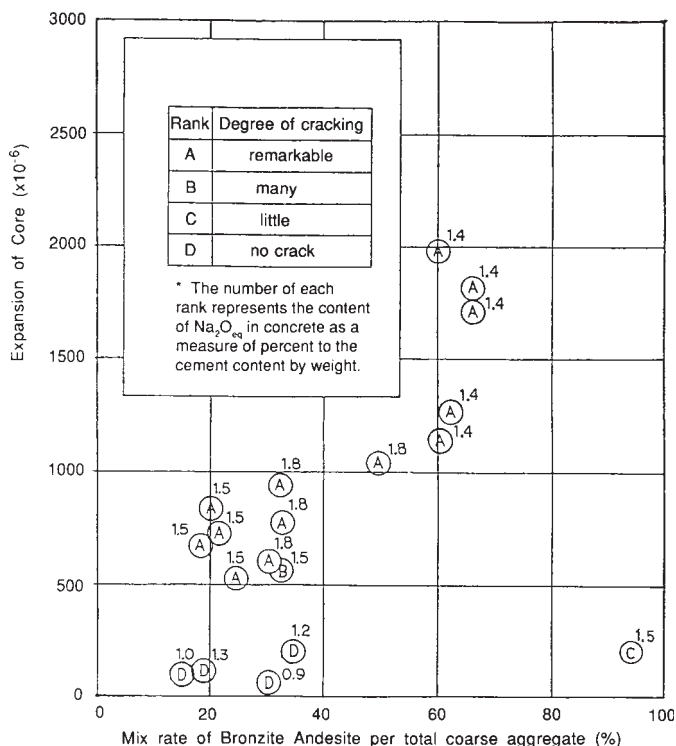
Figure 10.35 Degree of cracking and expansion of the drilled core.

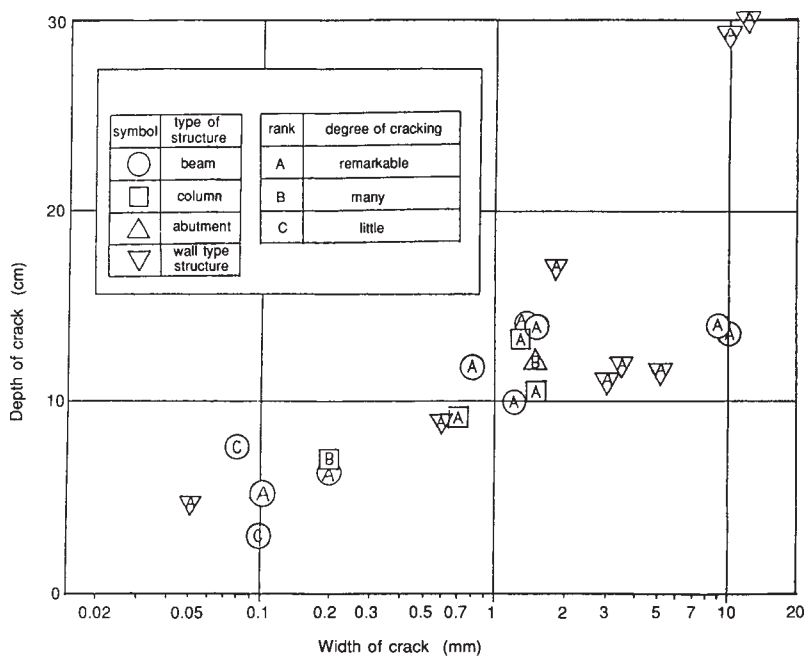
Figure 10.36 Relation between crack width and depth.

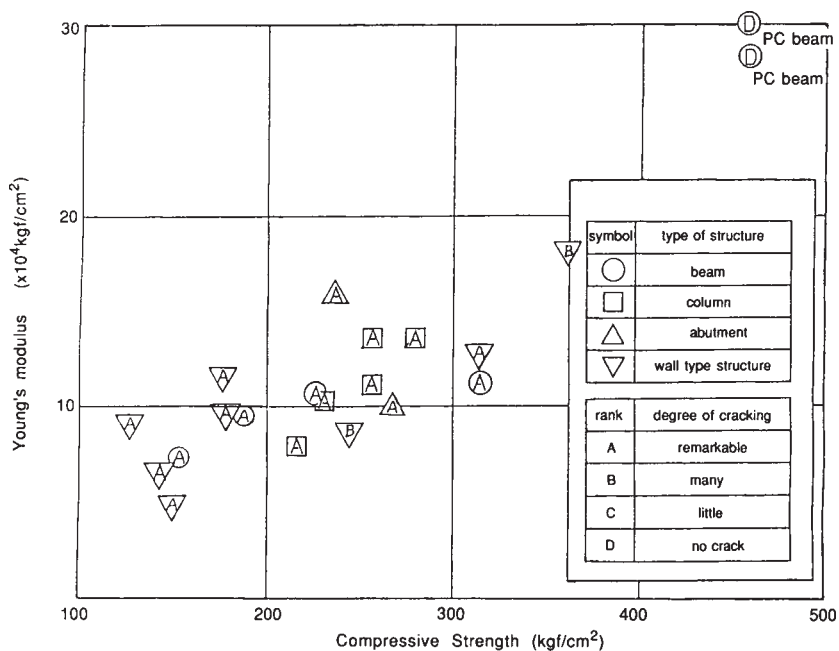
Figure 10.37 Compressive strength and Young's modulus of drilled cores.

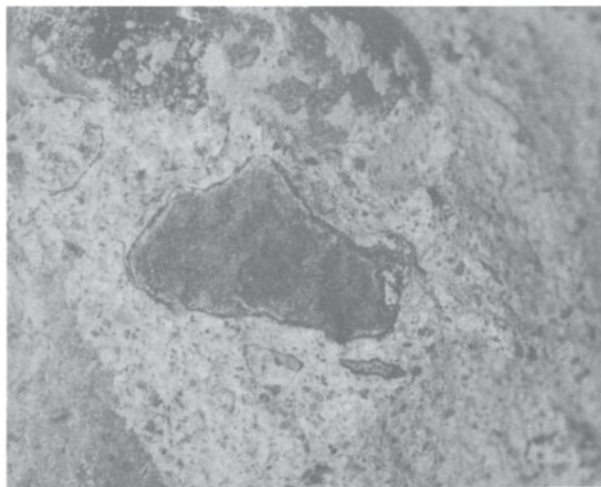
Figure 11.1 Concrete core sample showing dark reaction rim around the aggregates and typical ASR gel.

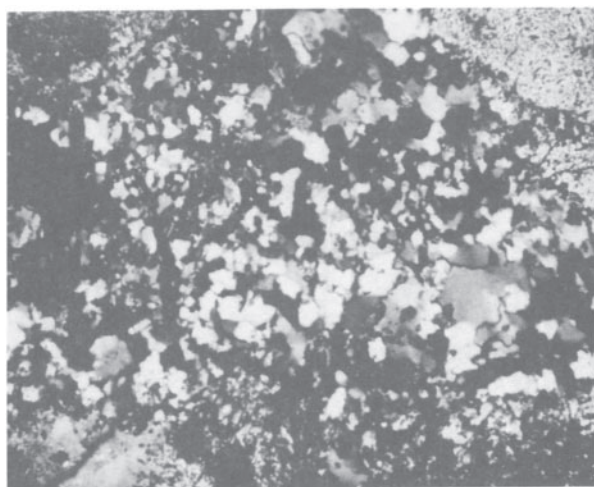
Figure 11.6 Quartz grains in granitic rocks showing undulatory extinction (crossed nicols, $\times 50$).

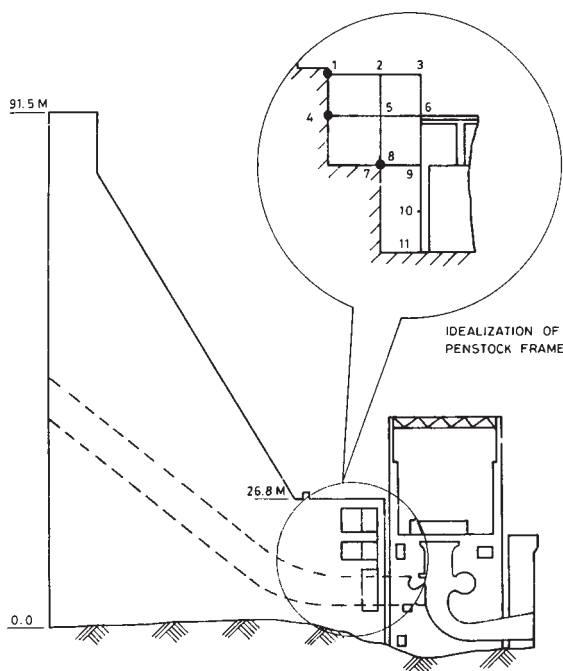
Figure 11.8 Concrete gravity dam and powerhouse structure-typical intake section.

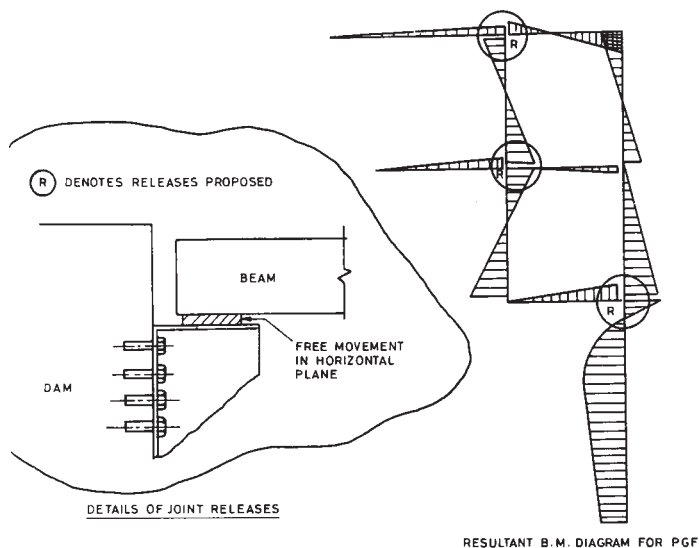
Figure 11.9 Bending moment in penstock gallery frame corresponding to induced horizontal and vertical displacements and reaction from the turbine block.

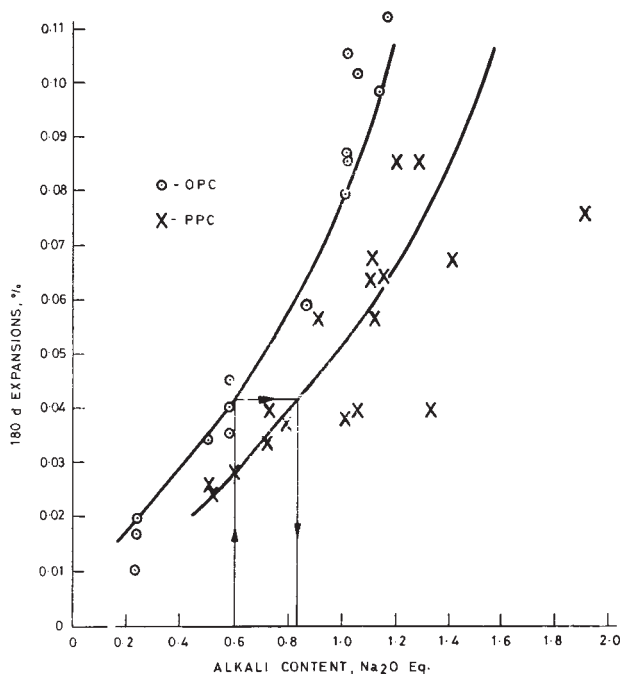
Figure 11.19 Relative performance of ordinary Portland cements and Portland pozzolana cements in mortar bar expansion tests with reactive aggregates.
