Microbes, Materials, and the Engineered Environment

# Failure Analysis of Microbiologically Influenced Corrosion

*Edited by Richard B. Eckert and Torben Lund Skovhus*

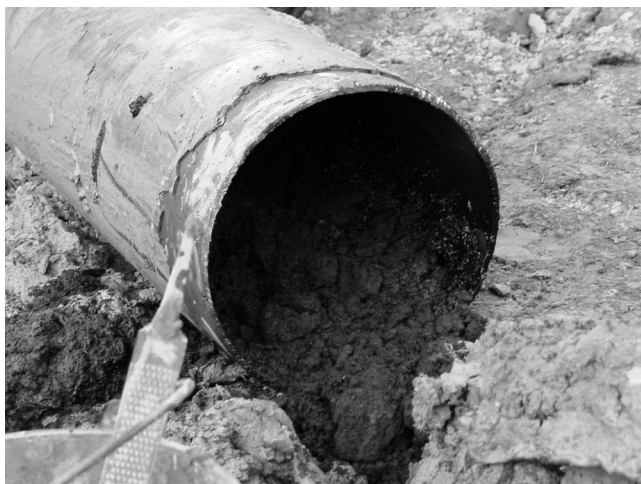
**FIGURE 3.1** Thick sludge found when investigating internal corrosion in a pipeline.

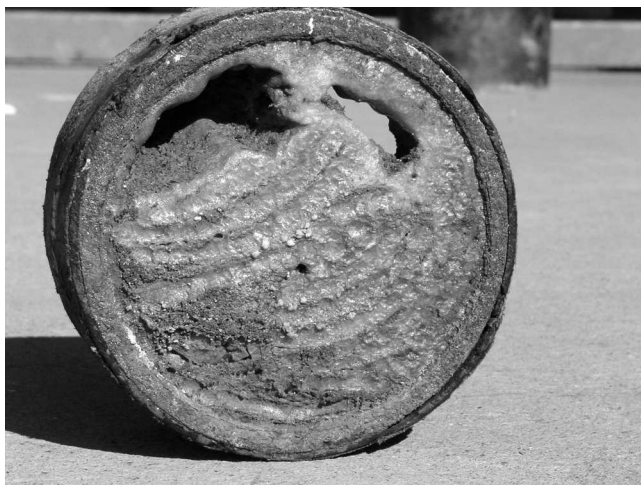
**FIGURE 3.2** A pipe cross section showing the accumulation of salt layers that occurred over years of service in a natural gas pipeline that experienced occasional upsets of high salinity brine.

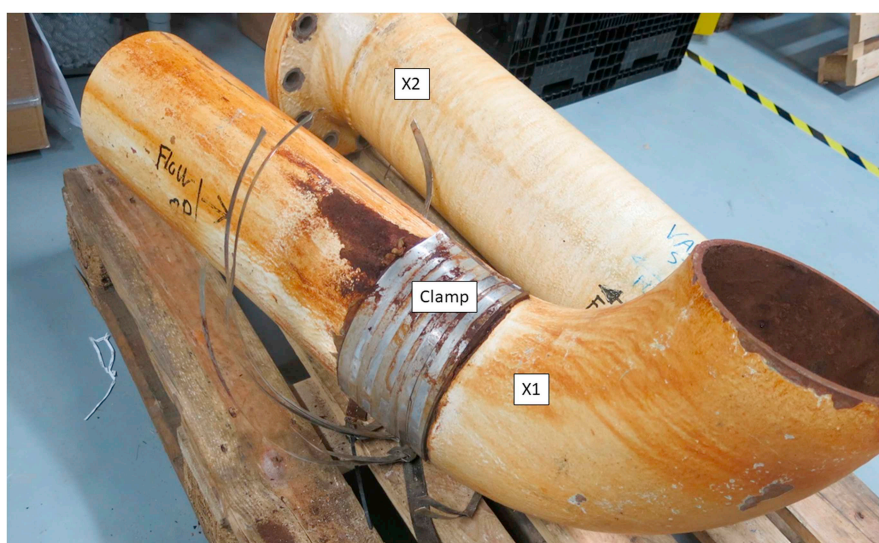
**FIGURE 7.3** Pipe samples denoted X1 and X2, respectively. Note that the leak point on X1 is wrap repaired by a glued rubber plate fixed to the pipe using metallic strips. X1: Spool section with reported pinhole leakage. X2: Spool section from 2.5 m downstream the leakage location, including flange.

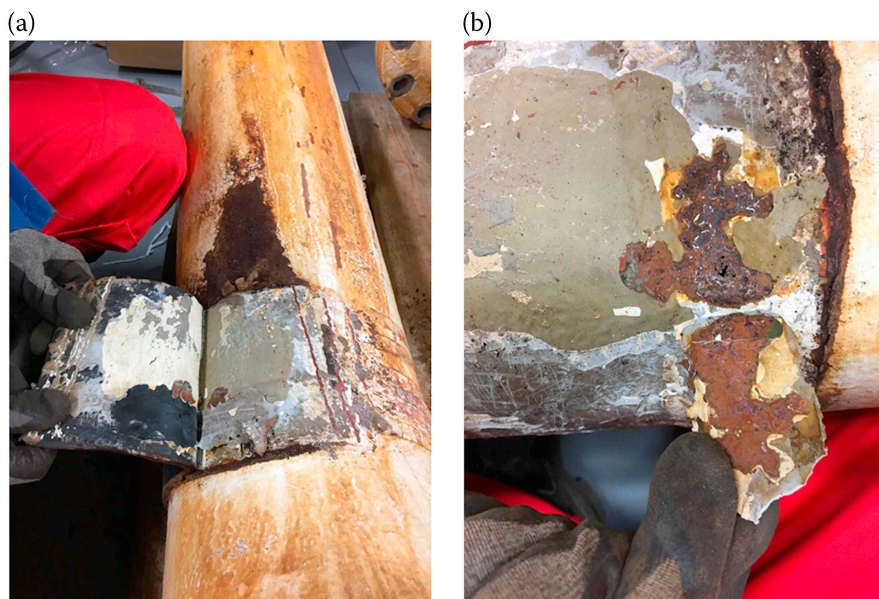
**FIGURE 7.6** Wrap repair being removed to reveal the leak point (A). Leak point visible after removal of wrap repair (B).

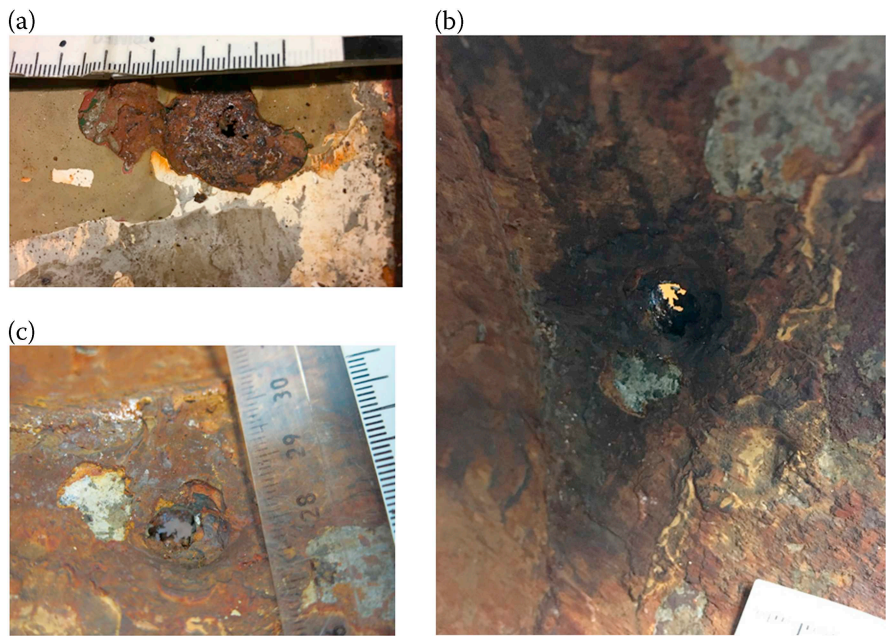
**FIGURE 7.7** Close-up of the leak point externally (A). Close-up of the leak point internally (B and C).

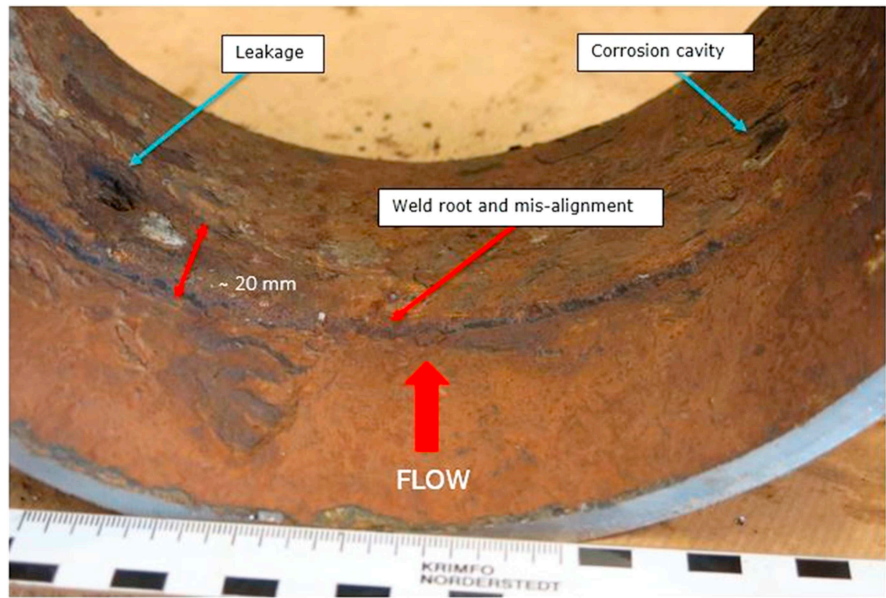
**FIGURE 7.8** Close-up photo of internal area comprising the leakage.

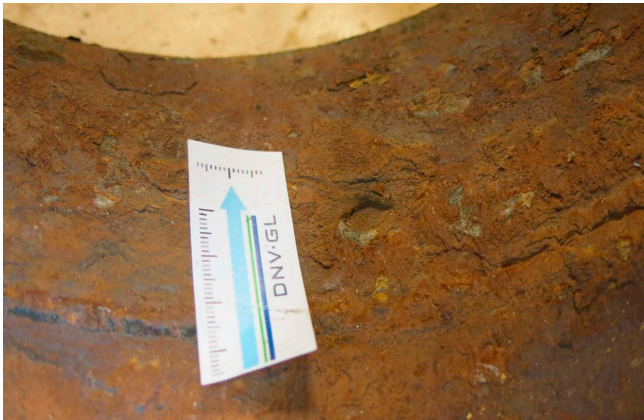
**FIGURE 7.9** Close-up photo of a local corrosion cavity approximately 20 mm from the weld root as also shown in Figure 7.8.

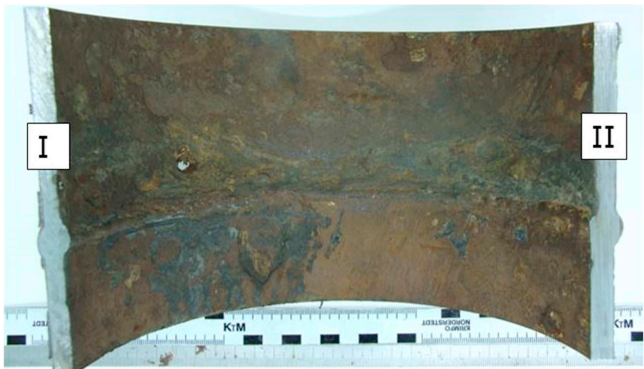
**FIGURE 7.10** Area close to weld after partly rinsing with Hexamine.

**FIGURE 7.11** Cross section cut I (top) and II (bottom) in Figure 7.10, indicate the corroded area on the bend side of the weld (approx. 30 mm from center of weld root).

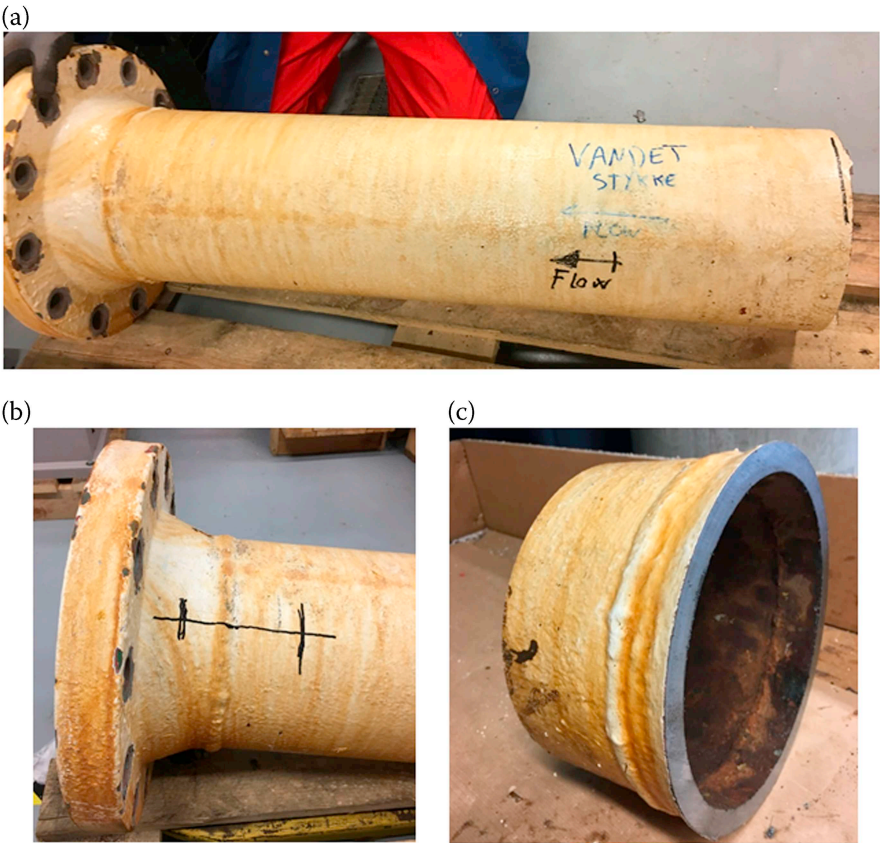
**FIGURE 7.12** Spool section X2, flow direction indicated on the pipe (A). Indication of sectioning of the weld on spool section X2 (B). Spool section X2 after sectioning (C).

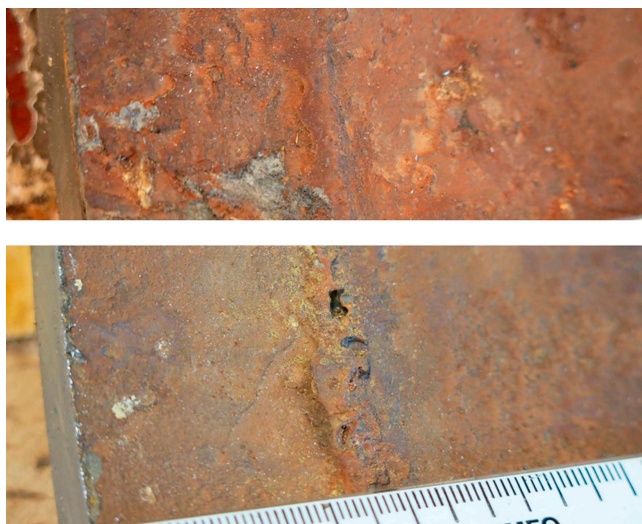
**FIGURE 7.13** Representative internal surface along the weld. General corrosion and some corrosion pits along the weld.

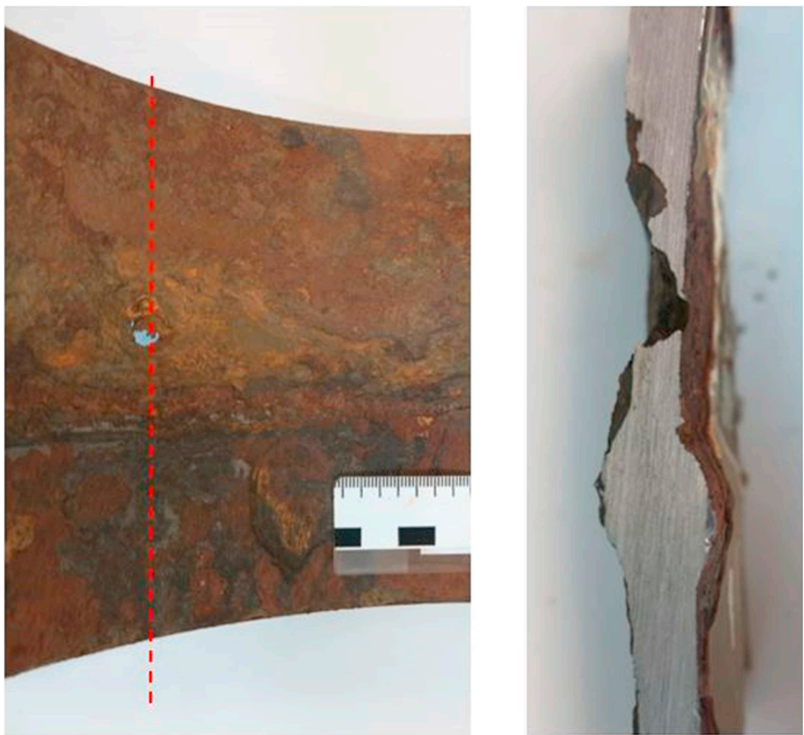
**FIGURE 7.15** Metallographic sample (cross section) cut out for micro examinations (X1 through leak site).

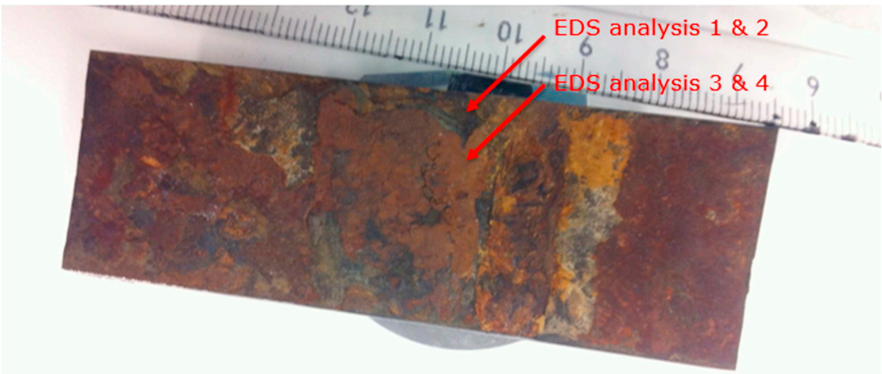
**FIGURE 7.18** Section prepared for EDS analysis (in area indicated by arrows).

Electron Microscope (SEM). Parts of the brownish corrosion product were removed, revealing the blackish corrosion product underneath. Chemical analysis was performed on the blackish surface (analyses 1 and 2) and the brownish surface (analyses 3 and 4), as illustrated in Figures 7.18 to 7.21, and the results are presented in Table 7.5.

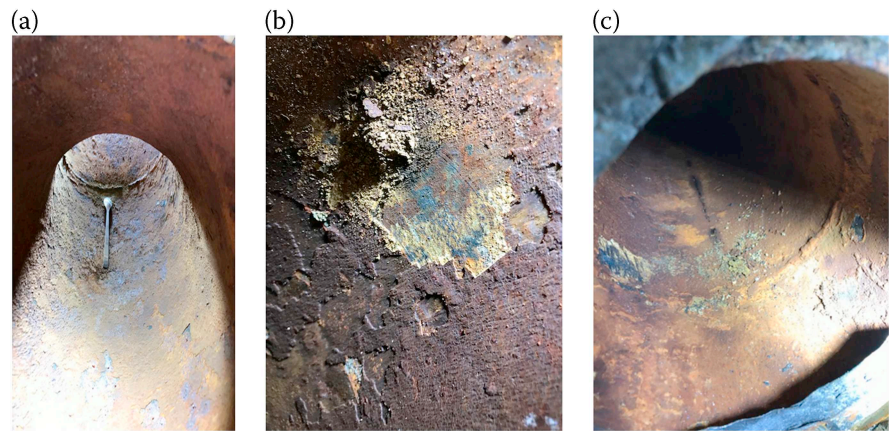
**FIGURE 7.22** Location for sample A, close to leak point in X1. Location for sample B, upstream the leak point in spool section X1. Location for sample C, downstream the leak point in spool section X2.

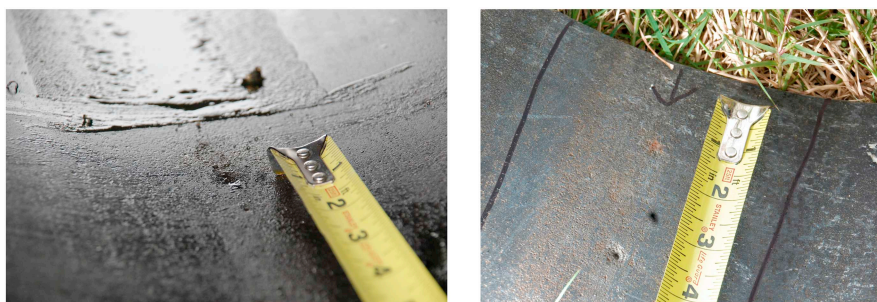
**FIGURE 10.1** Field photographs showing representative pits along the bottom of the pipeline, as-found (left) and after cleaning (right).

Figure 10.1 contains field photographs showing representative corrosion pits identified at the time of the excavation. As shown, the pits were small in diameter and located along the bottom of the pipeline. Additional discrete, isolated pits were observed along the bottom of the pipe. No evidence of significant general internal corrosion or accumulated solids was associated with the pits.

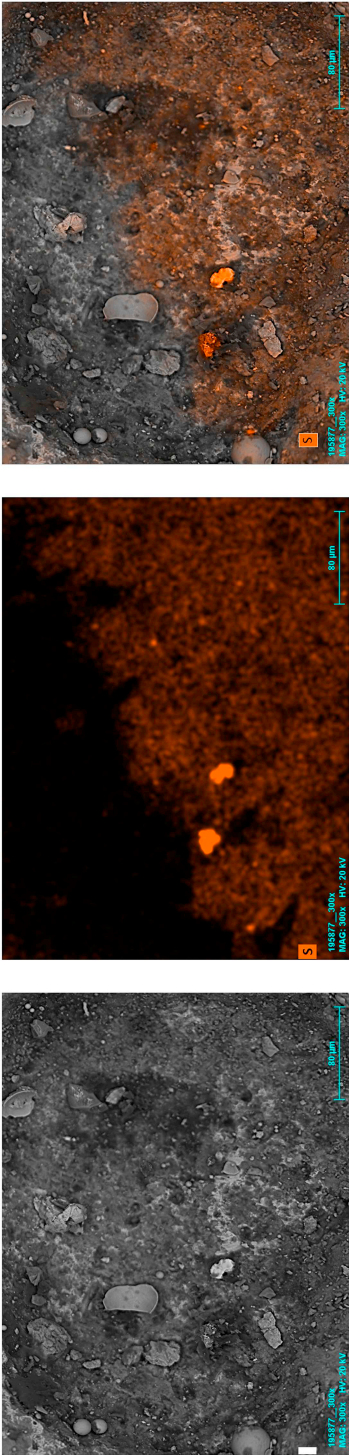
**FIGURE 10.3** SEM image and elemental maps looking down at the internal surface of a pipe coupon within an area of corrosion. The bright orange areas are discrete sulfur particles.

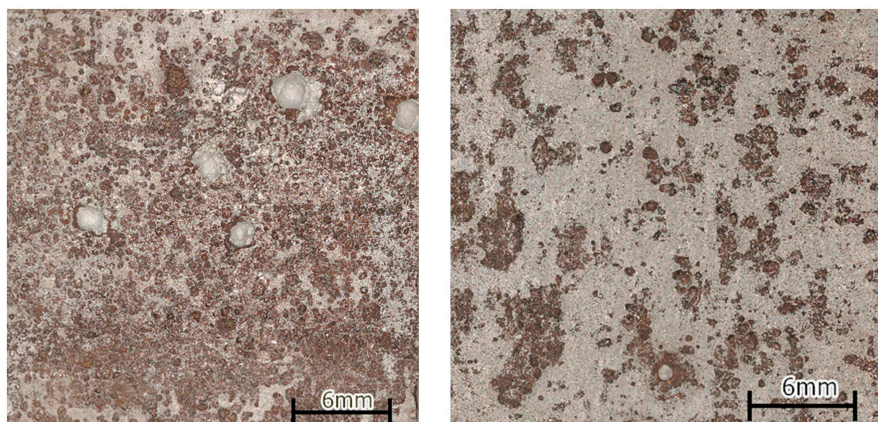
**FIGURE 10.5** Light photomicrographs showing corrosion pits on the internal surface of the pipe, after acid cleaning, at the 6:00 (left) and 6:30 (right) orientations.

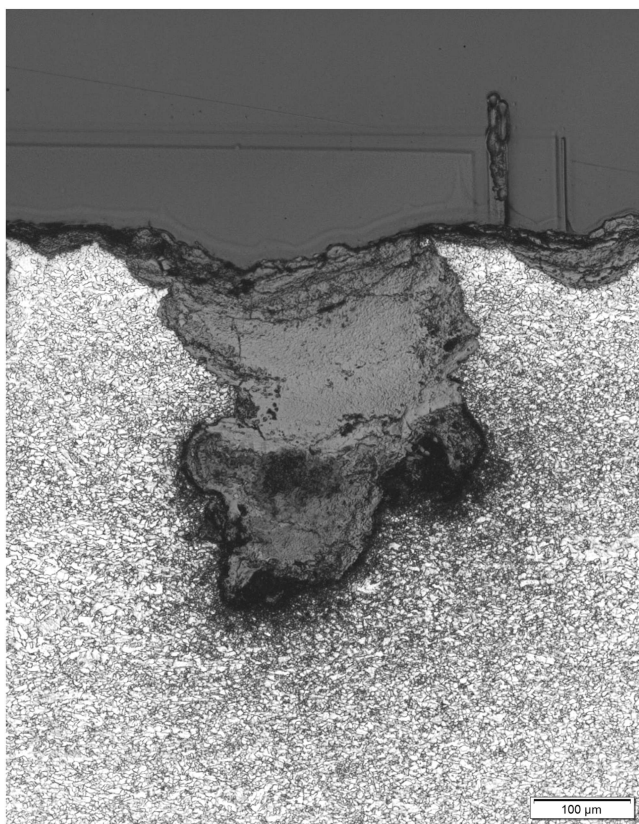
**FIGURE 10.6** Light photomicrographs showing a metallurgical cross section of a pit after polishing and etching with a 2% Nital.

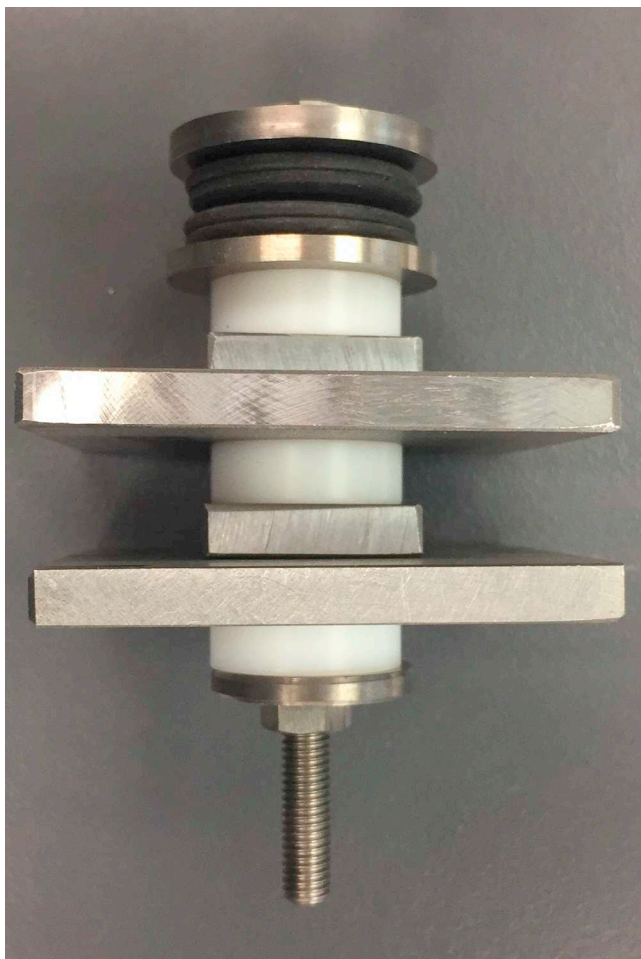
**FIGURE 11.1** Photograph of a metal-metal crevice assembly. The large metal samples (2205 duplex stainless steel) represented the cathode while the small metal samples represented anode (either nickel alloy 718 or 17-4 PH precipitation hardened stainless steel).

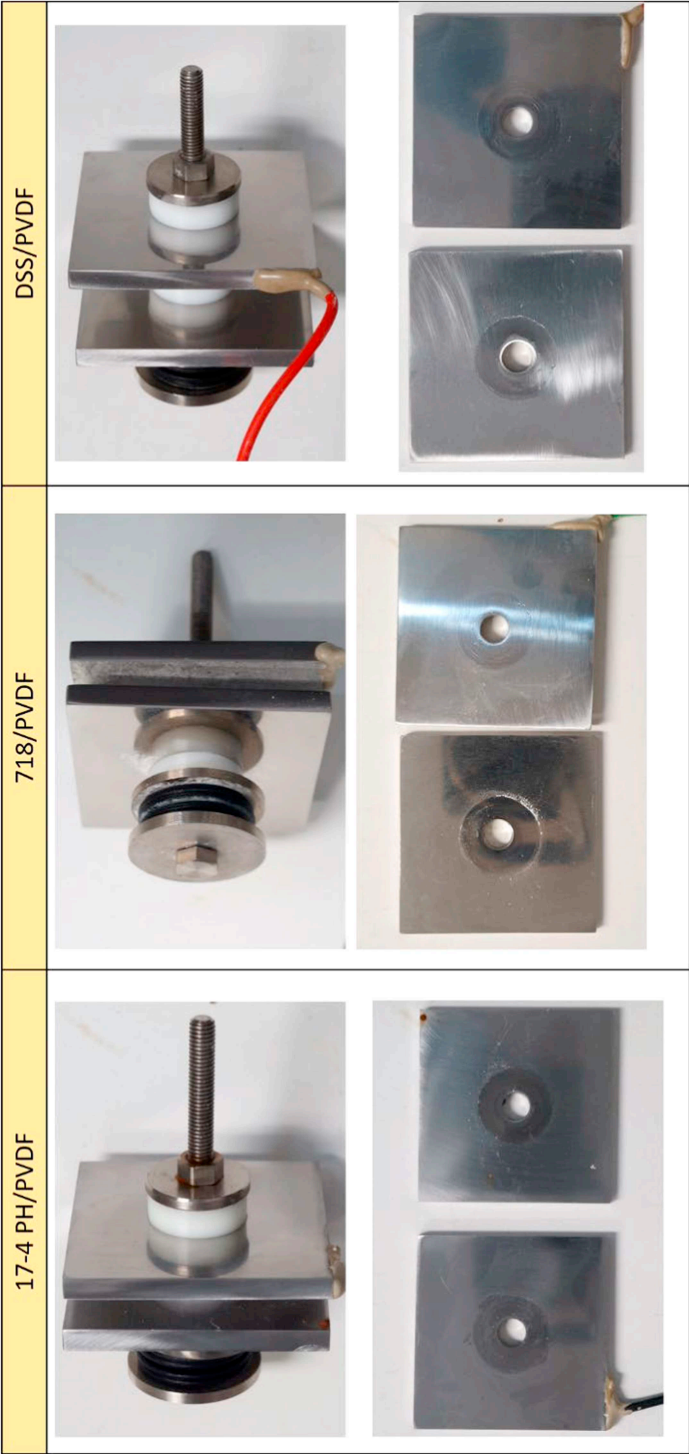
**FIGURE 11.7** Photographs of individual crevice samples (PVDF crevice formers) after eight-week exposure in the abiotic environment.

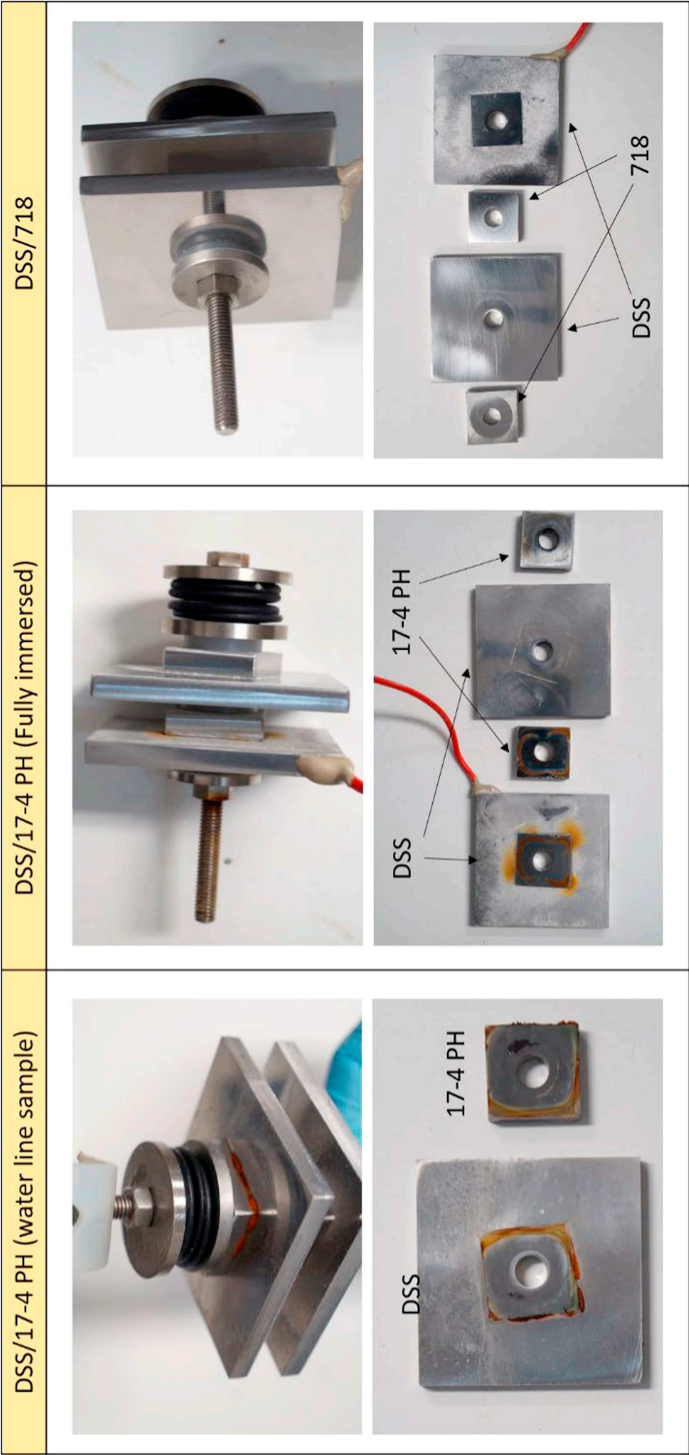
**FIGURE 11.8** Photographs of metal-metal crevice samples after eight-week exposure in the abiotic environment.

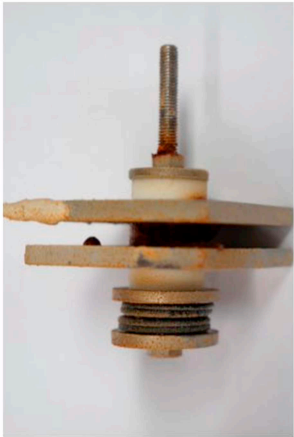
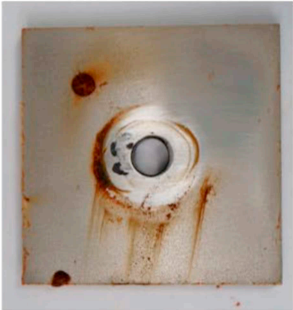
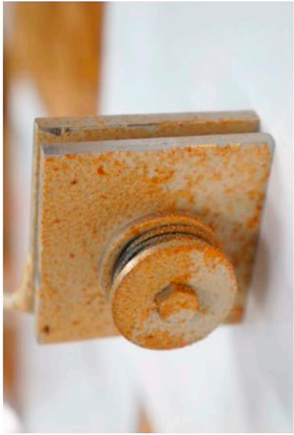
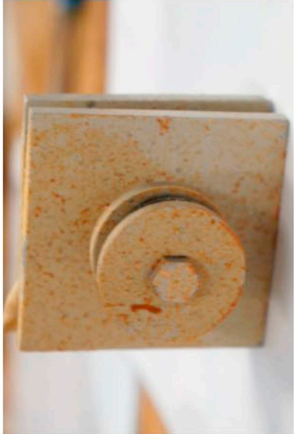
**FIGURE 11.9** Photographs of individual crevice samples after eight-week exposure in the biotic environment. Crevice corrosion is evident on 17-4 PH while DSS and 718 show no corrosion.

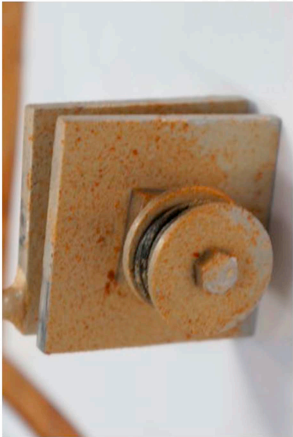
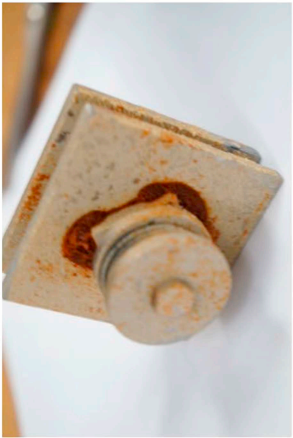
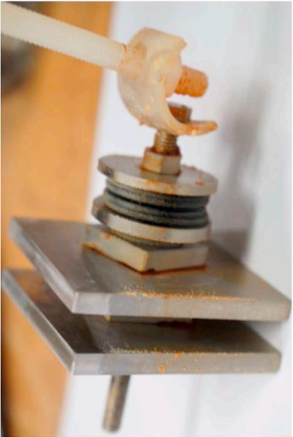
**FIGURE 11.10** Photographs of metal-metal crevice samples after eight-week exposure in the biotic environment.

For metal-metal crevice samples, only 17-4 PH exhibited severe corrosion, particularly in the presence of microbes where crevice corrosion was accelerated by >50 times to the equivalent of abiotic condition. Corrosion was not observed on 718 and DSS in metal/metal couples (Figure 11.11). The spring-loaded artificial crevice formed in the laboratory may not be representative of actual seal ring geometry, which has a tapered seal ring-hub interface. The tapered contact edge of a seal ring creates a crevice of increasing tightness, which could have delivered the optimal crevice, and geometry for initiation and propagation of crevice corrosion in the

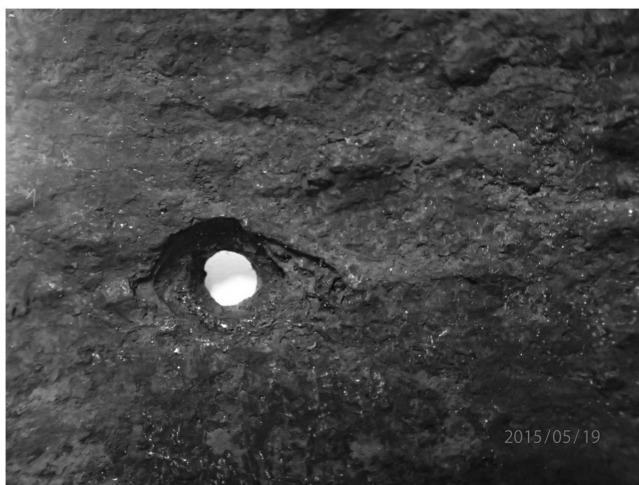
**FIGURE 12.1** Photo of interior pipe failure joint at 580 meters.

The first sample seen in Figure 12.1, Joint 580 meters, contained one through wall hole and several pits. The second sample seen in Figures 12.2 and 12.3, Burst Point, contained a through wall burst point and several pits and was located approximately 15 meters below the Joint 580 meters sample. Table 12.1 lists the samples analyzed for this failure investigation.

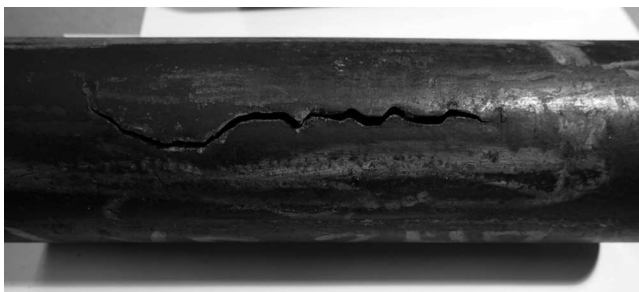
**FIGURE 12.2** Photo of outer diameter pipe failure sample burst point.

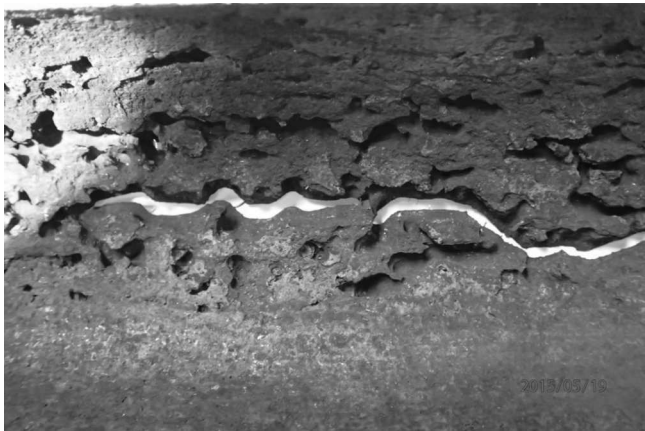
**FIGURE 12.3** Photo of inner diameter pipe failure sample burst point.

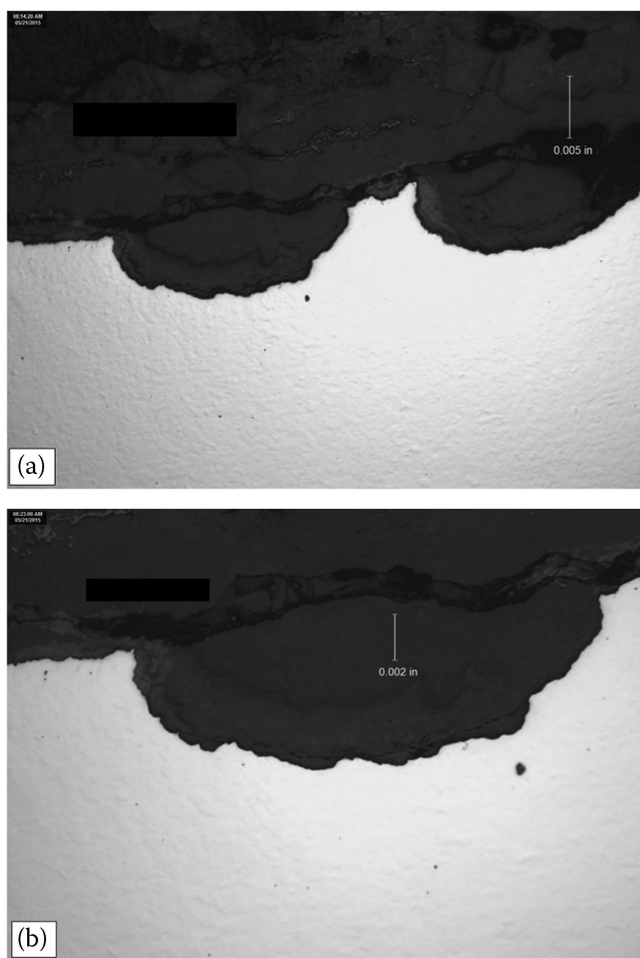
**FIGURE 12.5** a and b Microphotographs of corrosion pits in sample joint at 580 meters.

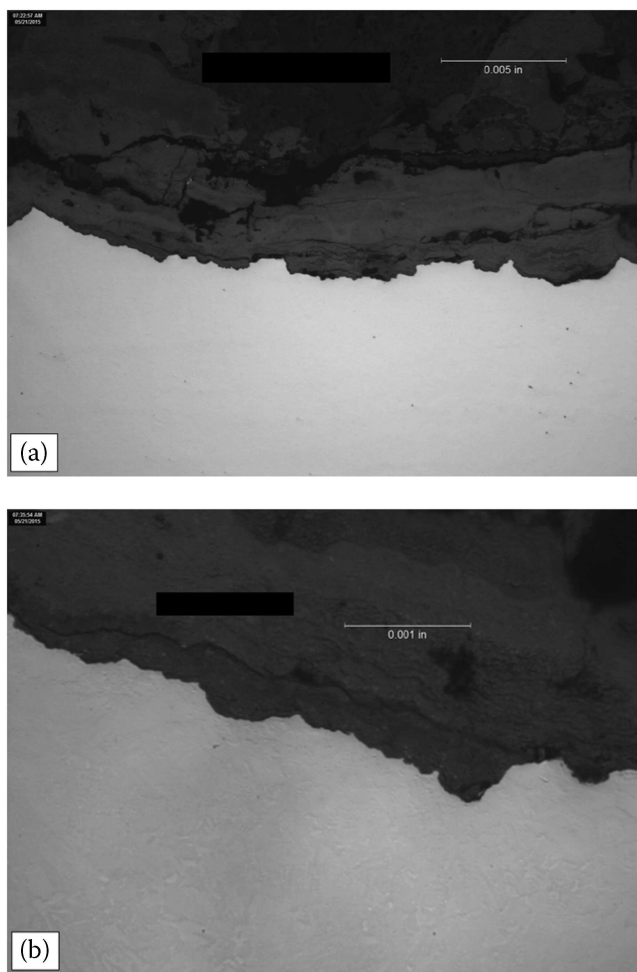
**FIGURE 12.8** a and b Microphotographs of corrosion pits in sample burst point.

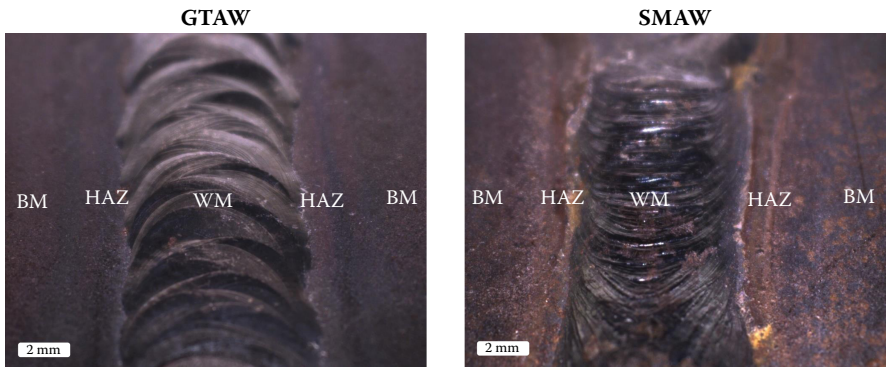
**FIGURE 13.1** Joints welded by gas tungsten arc (GTAW) and shielded metal arc (SMAW) before biocorrosion experiments. BM, base metal; HAZ, heat-affected zone; WM, weld metal.

Figure 13.1 shows the welded joints before the biocorrosion experiments. Note that the figure demonstrates just one sample out of a triplicate, showing each examined zone (BM, HAZ, and WM). Differences in the filler metal deposition, which was peculiar to each welding process, resulted in a lower surface roughness ( $R_a$ ) for WM-GTAW ( $6.8 \pm 0.5 \mu\text{m}$ ) than for WM-SMAW ( $8.7 \pm 1.4 \mu\text{m}$ ).

\* Zones of the welded joints were defined as illustrated in Fig. 13.1.

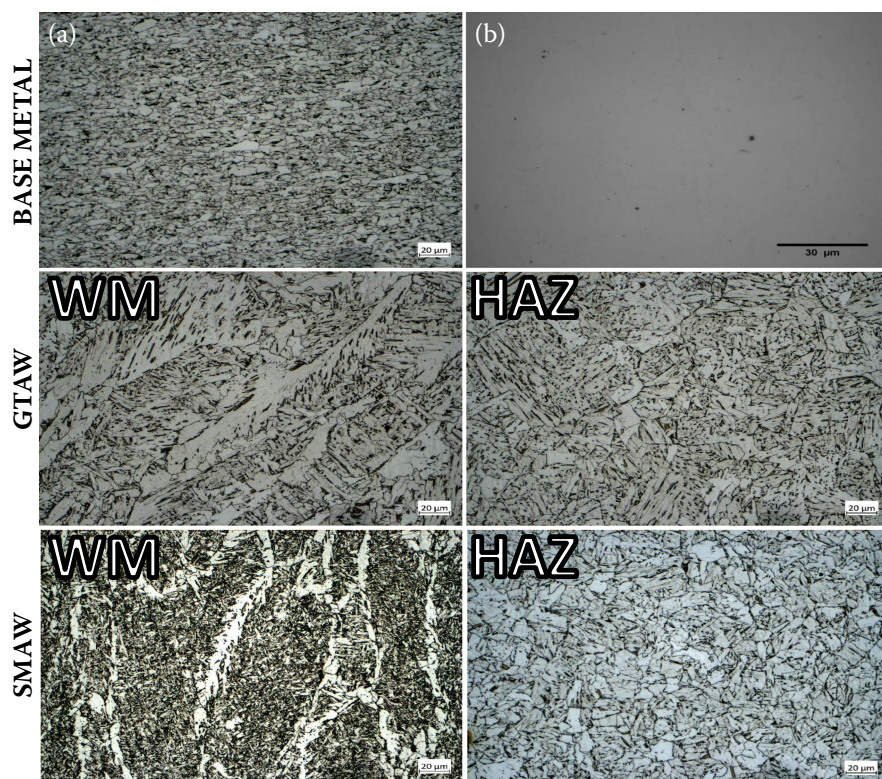
**FIGURE 13.3** Optical micrographs of the API 5L X65 base metal, (A) microstructure and (B) nonmetallic inclusions; and weld metals (WM) and heat-affected zones (HAZ) for gas tungsten arc welding (GTAW) and shielded metal arc welding (SMAW).

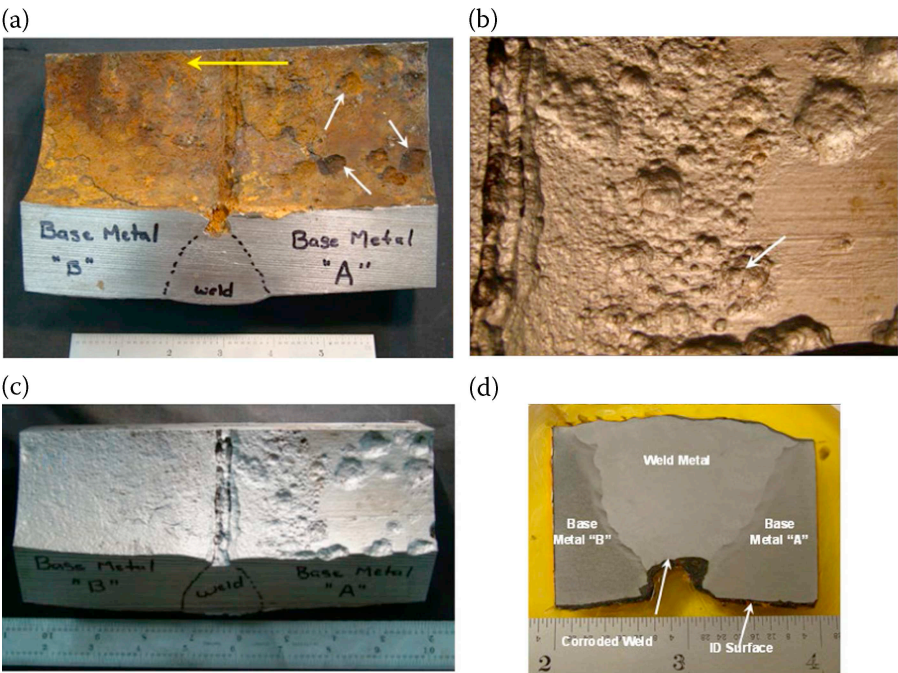
**FIGURE 14.1** (a) Photograph of the as-received pipe section showing differences in the degree of surface pitting in base metals A and B and a connecting weld area. The flow through the pipe was from the right to the left (yellow arrow). The degree of surface pitting was more pronounced on base metal A (white arrows) and particularly evident in (b) a close-up photograph. A photograph of the pipe section following bead-blasting to more clearly image the surface pitting morphology is seen in (c). (d) Photo of pipe cross section taken through the weld after it was mounted, polished, and etched with Nital to highlight microstructural features. The ruler in (a) and (d) is in inches.

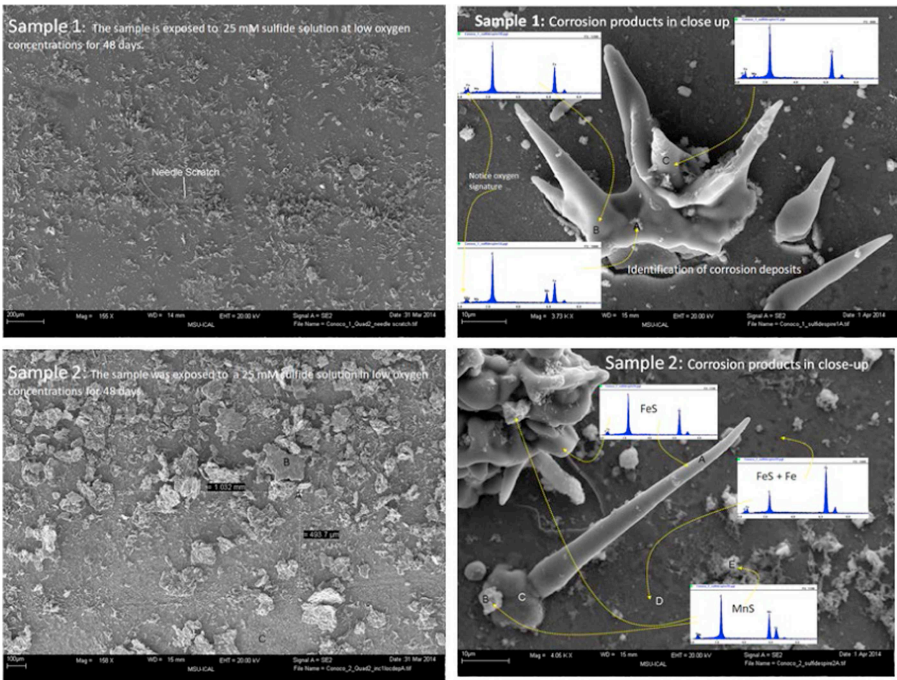
**FIGURE 14.7** SEM images of corrosion products on Sample 1 (top row) and Sample 2 (bottom row). The samples were exposed to a 25 mM sulfide solution under low oxygen concentrations in seawater for a period of 48 days. The column on the right shows close-up images of some of the corrosion products. Also shown in the close-up images are examples of EDX spectra from selected points on the corrosion products. These identify the elemental composition of these corrosion deposits. Insets in the right panels show mostly Fe-K<sub>α</sub>, K<sub>β</sub> (~5.4 & 7 KeV), Fe-L (~0.7 eV), S-K<sub>α</sub> (~2.3 KeV), Mn-K<sub>α</sub> (~5.9 KeV), and low concentrations of O-K<sub>α</sub> (~0.5 KeV) as seen in the images.

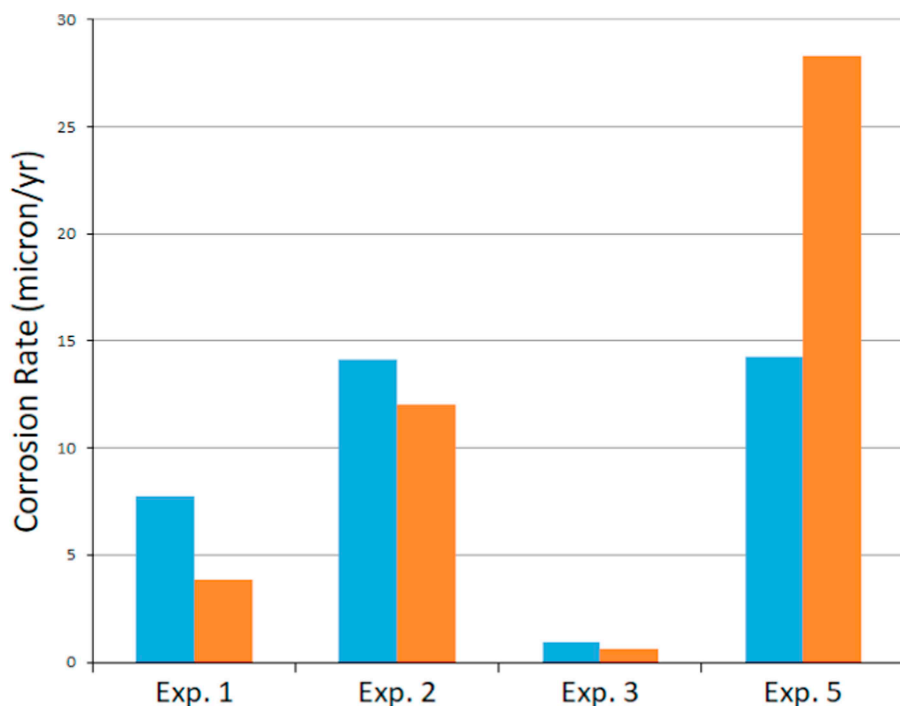
**FIGURE 14.8** Comparison of metal corrosion rates (Sample 1—blue bars; Sample 2—red bars) in sulfide-amended experiments. There was minimal or no differential corrosion in Experiments 1–3. These surfaces were likely passivated by high sulfide concentrations (see text for details) that slowed or prevented anodic and cathodic processes. When the coupons were exposed to sulfide and a low level of oxygen (experiment 5), differential corrosion was evident, presumably reflecting the reaction of oxygen with the passivating layer to reveal the base metals.

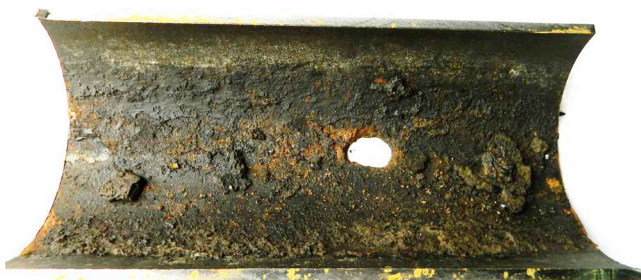
**FIGURE 15.1** Brown-orange deposit near perforation and thick, black, loose deposits away from perforation (5 to 7 o'clock) observed on FL-1 sample 1. SRB were detected in this deposit.

As mentioned previously during seawater flooding in reservoirs, due to water breakthrough, SRBs [mesophilic (m-SRB) and thermophilic (t-SRB)] possibly was introduced into the well fluid and proliferated in the flowlines during stagnant condition at low spots, forming biofilms. Bacterial action reduces the sulfate present in the water to sulfide, using the hydrogen to form hydrogen sulfide. The hydrogen sulfide reacts with the dissolved ferrous iron, which is released at the anode to form an iron sulfide precipitate (Von Holy 1987). Formation of such black-colored corrosion product on failed sections of all the three flowlines can be seen from Figures 15.1, 15.7, and 15.8 and thin FeS film in Figure 15.2 and identified as iron sulfide by XRD in Figure 15.13.

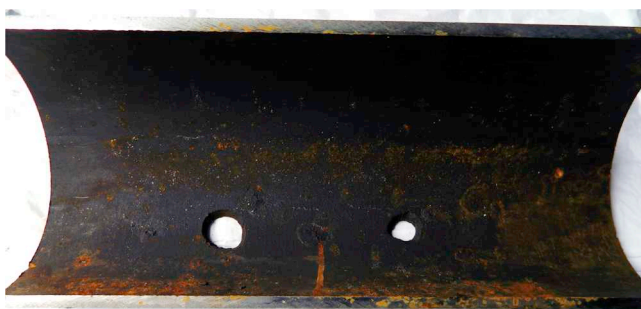
**FIGURE 15.2** Thin, black deposit near perforation and away from perforation (5 to 7 o'clock) observed on FL-1 sample 2. No SRB were detected in this deposit.

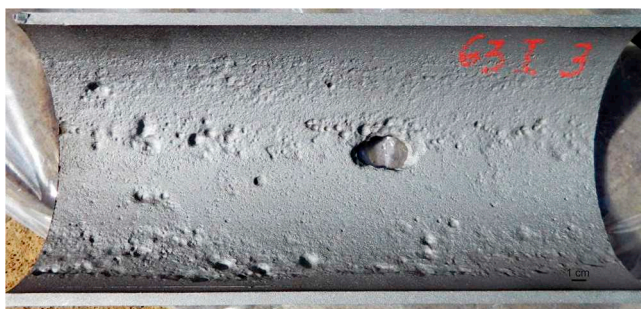
**FIGURE 15.3** Perforation at 6 o'clock, deep pitting with thinning on bottom section (5 to 7 o'clock) observed on sweep blasted section of FL-1 sample 1.

After removing deposits, the general corrosion and corrosion pits were visible on FL-1 (Figures 15.3 and 15.4).

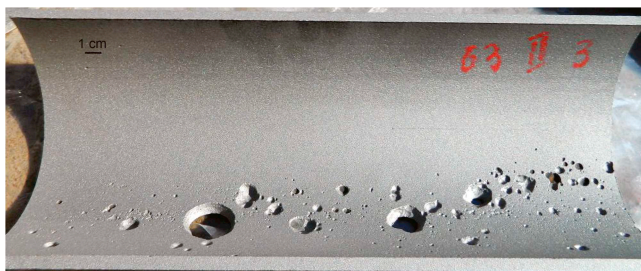
**FIGURE 15.4** Perforation, deep pitting without thinning on bottom section (5 to 7 o'clock) observed on sweep-blasted section of FL-1 sample 2.

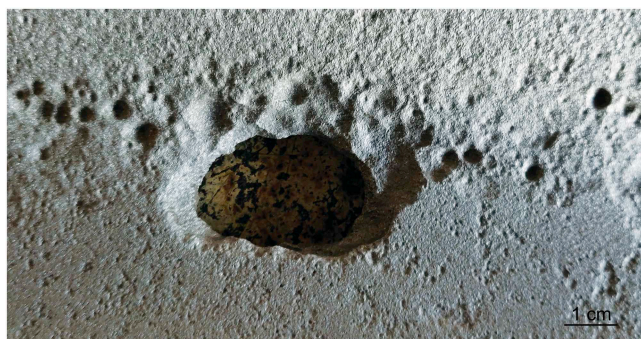
**FIGURE 15.5** Close-up photograph showing several deep pits surrounding perforation on FL-1 sample 1. Pit boundary diffused and sloped.

Several deep pits surrounding the perforation were observed on one section while isolated perforation was observed on the other section of FL-1 (Figures 15.5 and 15.6).

Figures 15.5 to 15.12 show the pitting morphology on all of the leaked flowline sections. The pits appeared to be elongated with etched sides, slopy edges, and satiny bottoms. A typical oblong-shaped corrosion pit with two or more interconnected pits with the perforation in the center of the bigger pit can be seen in Figure 15.11. Smooth, silky surface can be seen in Figure 15.12, while pits within pits arrangement is visible in Figure 15.10. Similar features such as cup-shaped pits within pits on carbon-steel in cooling water service have been characterized and documented as MIC (API RP571 2003). However, in crude oil service, the presence of acid gases can simultaneously corrode metal surfaces, thereby changing the MIC pit morphology (Skovhus et al. 2017).

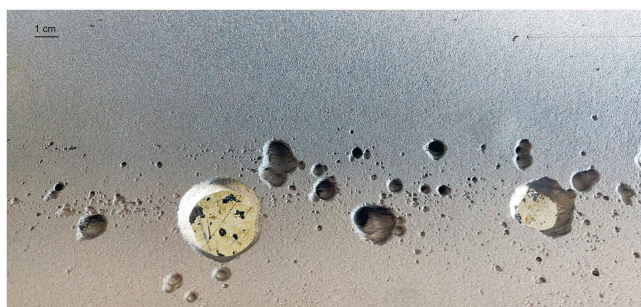
**FIGURE 15.6** Close-up photograph showing perforation on FL-1 sample 2. Perforation pit boundary is sharp and not surrounded by pits.

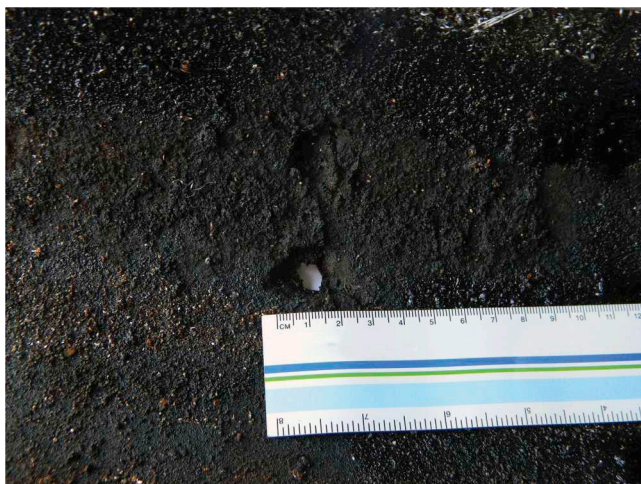
**FIGURE 15.7** Blackish deposit near and away from the perforation (5 to 7 o'clock) observed on FL-4 sample 1 section taken from underground portion of the flowline.

Thick, heavy deposition was observed on the cut sections of flowline FL-4 (Figure 15.7). After prolonged exposure, the deposits turn orange-brown due to oxidation of iron sulfides (Figure 15.8).

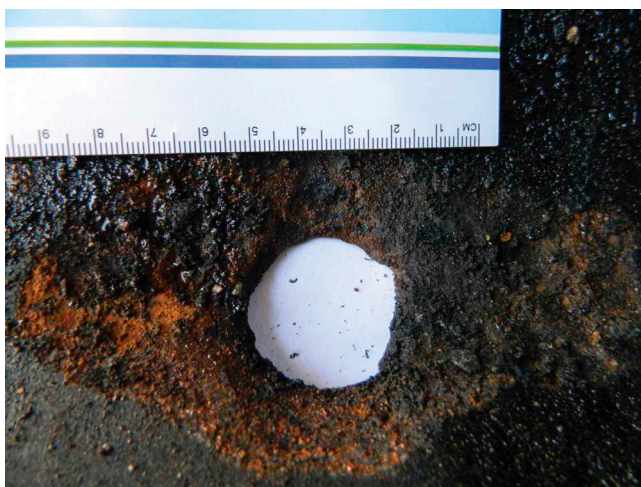
**FIGURE 15.8** Blackish and orange-brown deposit near the perforation (5 to 7 o'clock) observed on FL-4 sample 2 section taken from aboveground portion of the flowline.

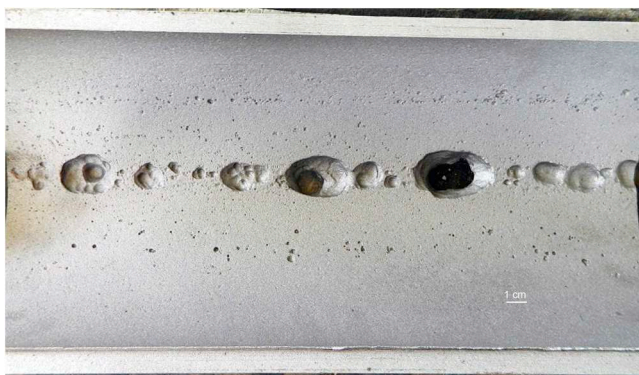
**FIGURE 15.9** Pitting and channels between two perforations along the bottom of FL-4 sample 1.

Continuous pitting and perforation was observed on the sweep-blasted sections of flowline FL-4 sample 1 (Figure 15.9) while pits within pits arrangement were visible in FL-4 sample 2 (Figure 15.10).

A closer look of Figure 15.9 indicated pits growing together along the axis (Figure 15.11). Smooth, silky surface was observed on the FL-6, sample 2 (Figure 15.12).

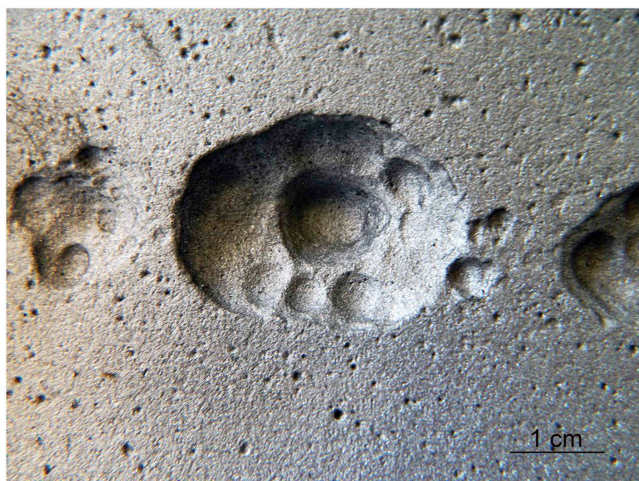
**FIGURE 15.10** Pits within pits arrangement (5 to 7 o'clock) on FL-4 sample 2. Diffused boundary between large and small circular pits with sloped edges can be seen.

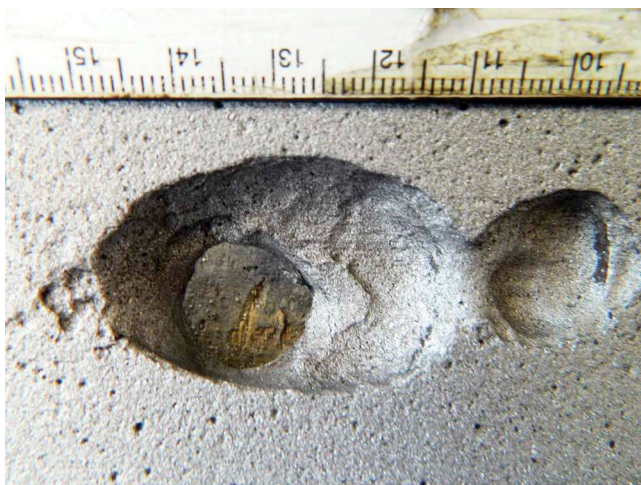
**FIGURE 15.11** Typical association of a large pit with a small pit on FL-4 sample 2.

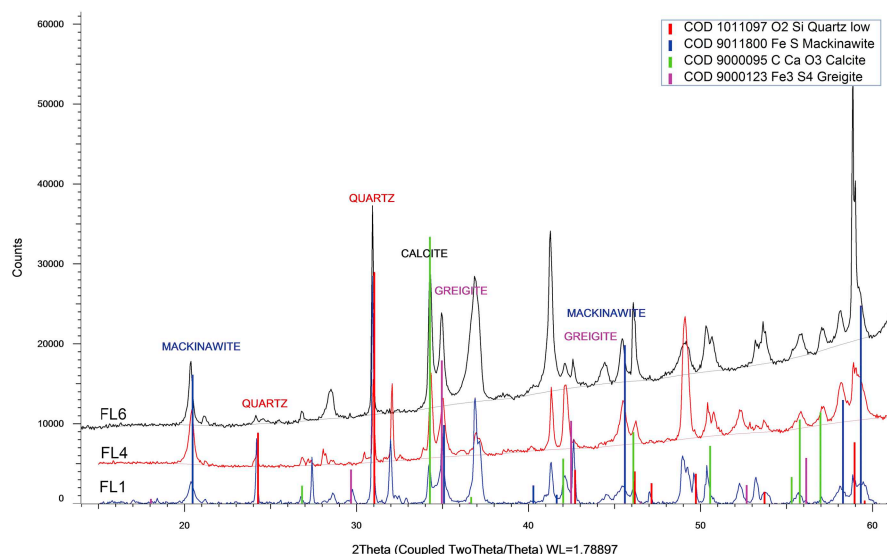
**FIGURE 15.13** XRD of deposits collected from FL-1, FL-4, and FL-6 showing iron sulfide corrosion products with varying concentrations.

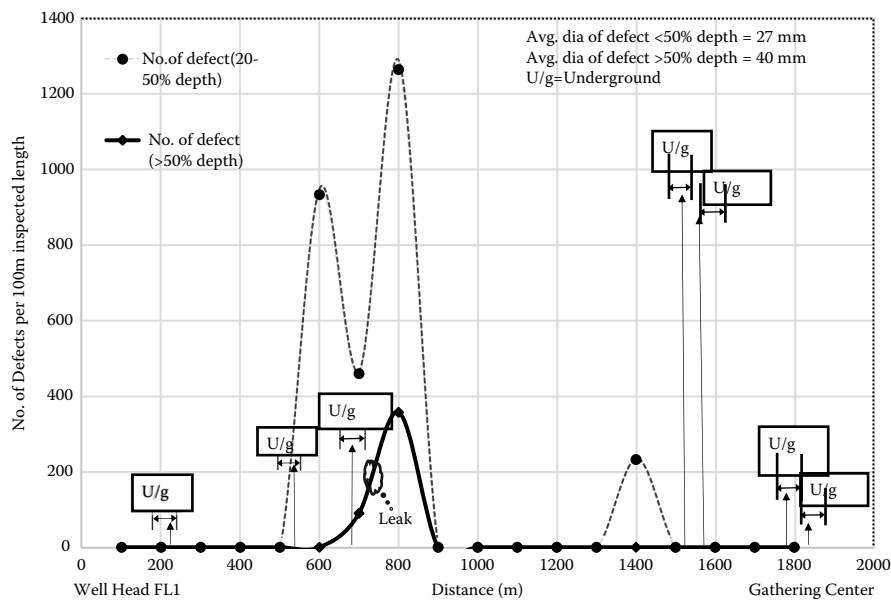
FIGURE 15.14 Defect distribution on FL-1 evaluated based on the LRUT data.
