Microbes, Materials, and the Engineered Environment

# Failure Analysis of Microbiologically Influenced Corrosion

*Edited by Richard B. Eckert and Torben Lund Skovhus*

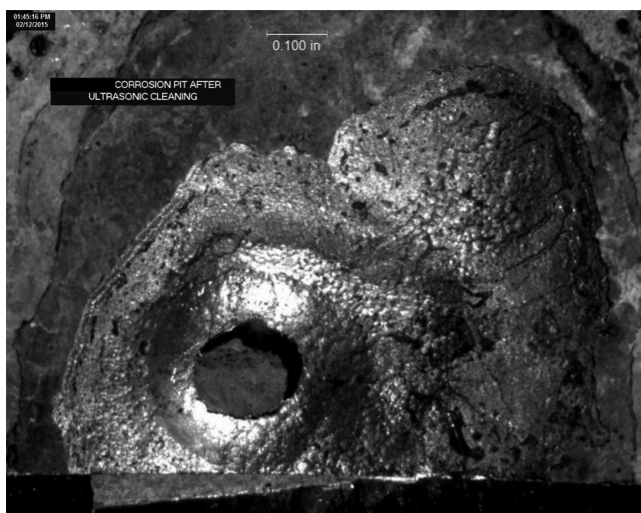
**FIGURE 16.5** Micro photo of interior pipe hole after ultrasonic cleaning

The morphology of the surrounding pitting of the hole is elliptical in nature (not uniform).

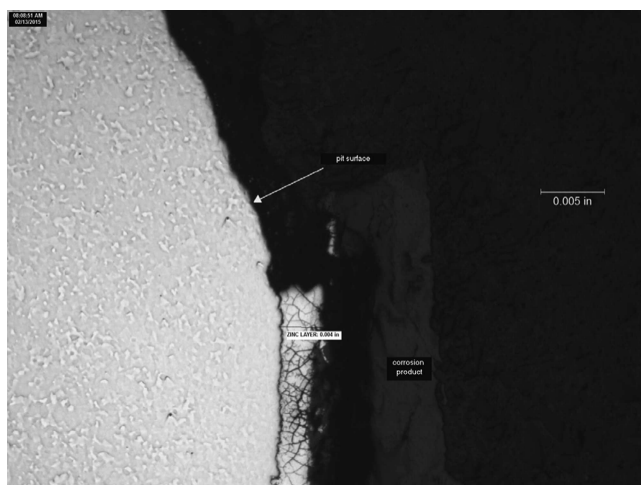
**FIGURE 16.8** Cross section of pipe pit surface.

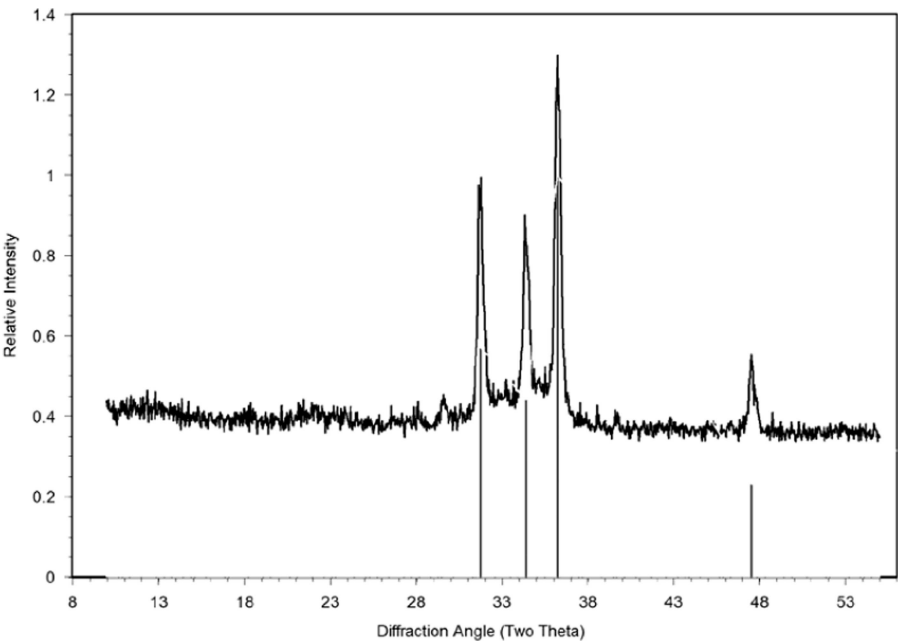
**FIGURE 16.9** XRD pattern for debris sample

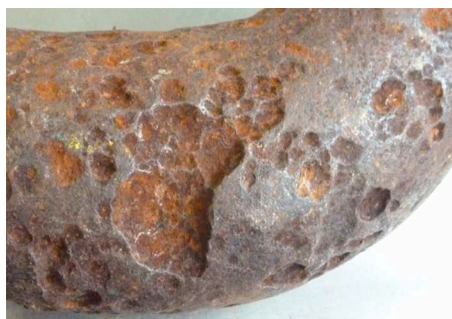
**FIGURE 17.1** Part of corroded steel chain link (76 mm diam.) showing evidence of highly localized corrosion after removal of rust layers.

Discovery of the localized corrosion shown in Figure 17.1 during routine inspections as part of a major research study (SCORCH-JIP) to ascertain the effect of operating in the tropics (Lee et al., 2015) caused considerable alarm because of the potential implications for FPSO operational safety. This led the research project to investigate the potential reasons for such corrosion, noting that the FPSOs involved were many kilometers offshore and thus in what were assumed to be unpolluted ocean waters. However, water quality testing showed that this was not the case and that there were high concentrations of Dissolved Inorganic Nitrogen (DIN) in the seawaters, indicating that microbiologically influenced corrosion (MIC) was likely to be involved (Melchers, 2014a). The next section reviews the background for the link between MIC and DIN in seawater, drawing on earlier work for accelerated low water corrosion (ALWC) and the correlation between DIN and MIC for

The chain links in Figures 17.1 and 17.7 show that the most severe corrosion is highly localized and that large areas of the chain links have experienced much less corrosion, mainly in a form that could be classified as ‘uniform’ or ‘general’ corrosion. A parallel situation was found for the corrosion of vertical steel piling (Melchers and Jeffrey, 2013). Particularly in seawaters with elevated DIN concentrations usually there is a contrast between the depth of highly localized corrosion, in the so-called accelerated low water corrosion (ALWC) immersion zone, compared with the corrosion for the remainder of the pile in the immersion zone (Figure 17.6). For the present analysis it should be noted that the surface area extent of the localized corroded region for ALWC is comparable in size to the more severe cases of localized corrosion of the 76 mm diameter chain links. In both exposure situations the concentration of DIN in the seawater appears to be an indicator of the severity of localized corrosion (Figure 17.6 and Table 17.1).

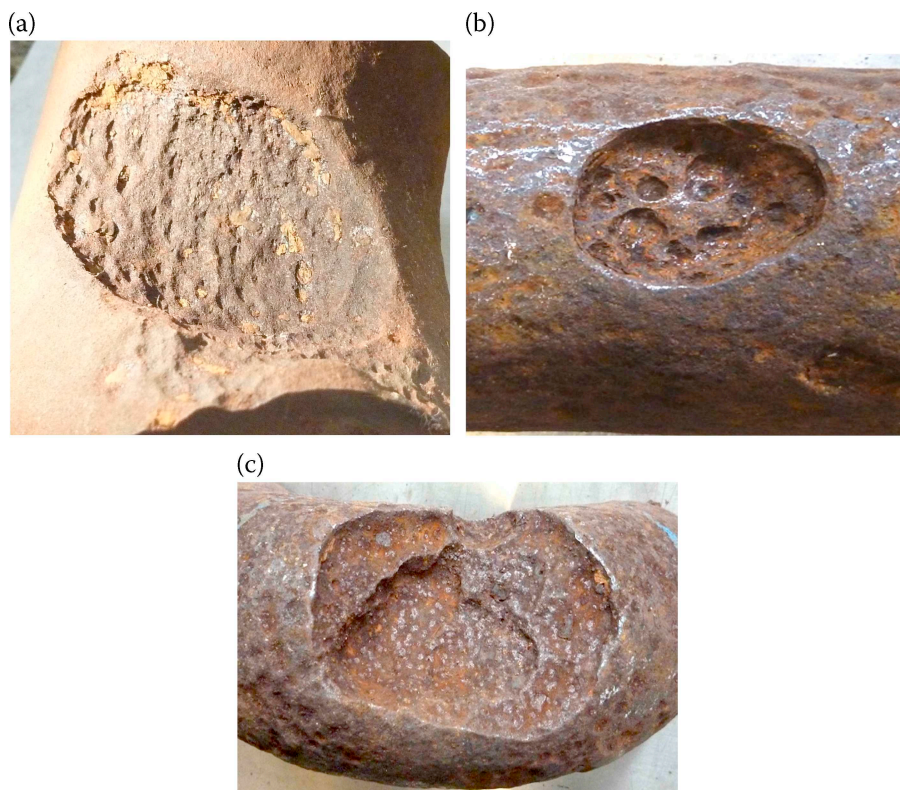
**FIGURE 17.7** Close-up views of regions of severe localized corrosion of 76 mm diameter chain links after 8–15 years exposure in near-surface immersion conditions and subsequent water jet cleaning and grit-blasting to remove the corrosion products. Figure 17.7(a) shows that the grit-blasted surface still has some remnants of corrosion products in the pits. Figure 17.7(b) shows evidence of pits within the localized corroded zones and Figure 17.7(c) shows plateaus of corroded surfaces within the larger localized regions of corrosion, with total depth of penetration some 20–30 mm.

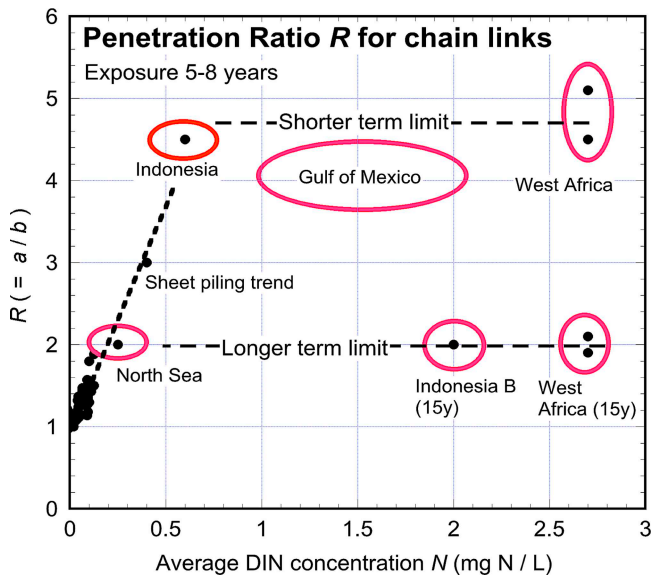
**FIGURE 17.10** Plot of ratio  $R$  against DIN  $N$  for both the ALWC cases and the trend from Figure 17.6, with extreme localized corrosion data from chain links added. The effect of increased exposure period from ‘shorter term’ to ‘longer term’ is shown as producing a reduction of  $R$ , consistent with the field data.

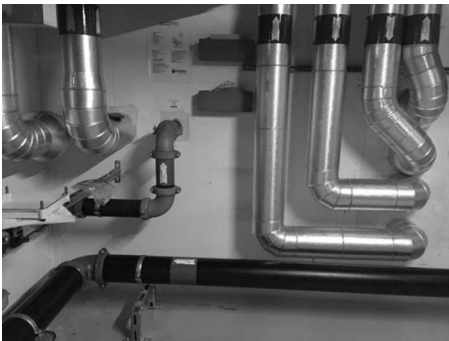
**FIGURE 18.2** Inlet pipe in DN150 standard from the Knowledge Center. The bottom pipe was replaced April 2018 due to corrosion. The pipe had been in operation for five years.

Inlet pipes from three different parts of the hospital have been replaced due to corrosion. The pipes varied in size, length, and number of years in operation before being replaced, see Table 18.1 and Figures 18.2–18.4. These three pipe spools were the subject for the experimental work in determining the main cause of the corrosion problems.

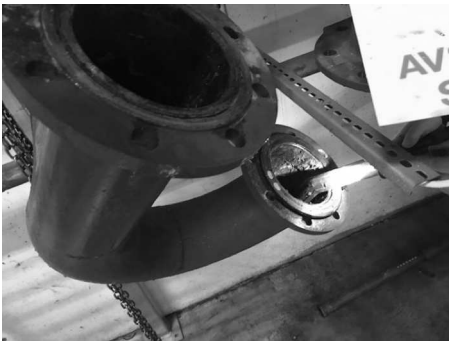
**FIGURE 18.3** Inlet pipe in DN150 standard from the Women's and Children's Center. The pipe was a 1.5-meter U-bend and was replaced in 2017 due to corrosion. The pipe had been in operation for 10 years.

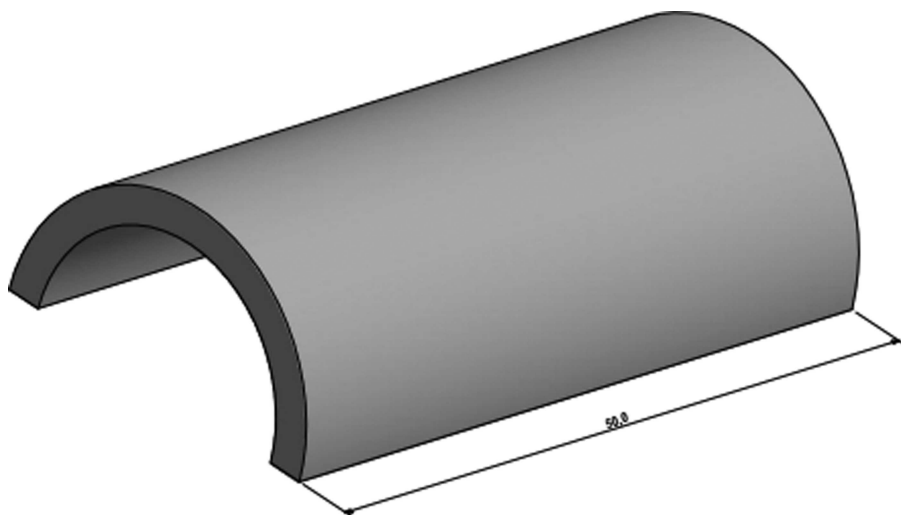
**FIGURE 18.6** Sections of pipe cut to 50 mm width.

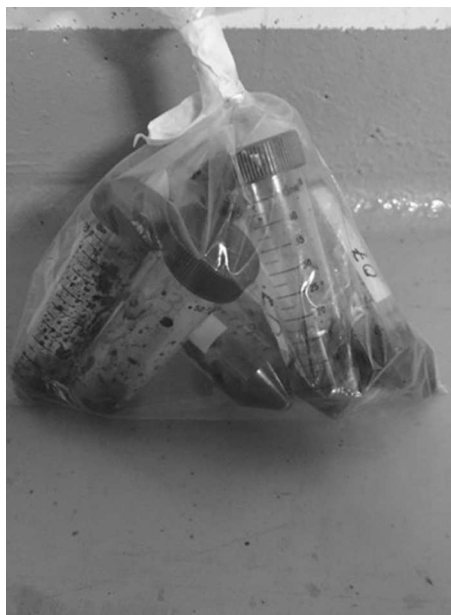
**FIGURE 18.9** Sample holders consisting of 50 ml tubes filled with 5–10 ml of corrosion product each.

The sample holders consisted of 50 ml tubes which were filled with 5–10 ml of corrosion product, shown in Figure 18.9. The samples were then placed in a cooler with dry ice so that the temperature would stay below  $-20^{\circ}\text{C}$ .

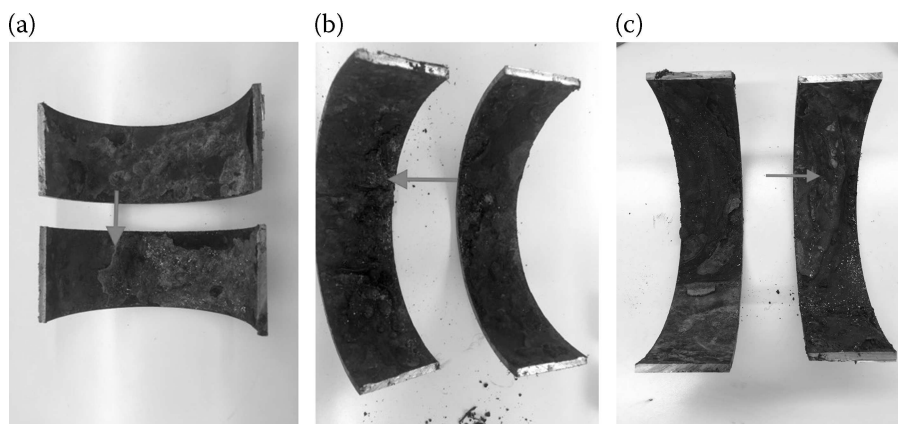
**FIGURE 18.10** Metal samples in carbon steel from the pipe in the 1902 building, the Women’s and Children’s Center, and the Knowledge Center. The arrows indicate the highest measured tubercle in the pipes.

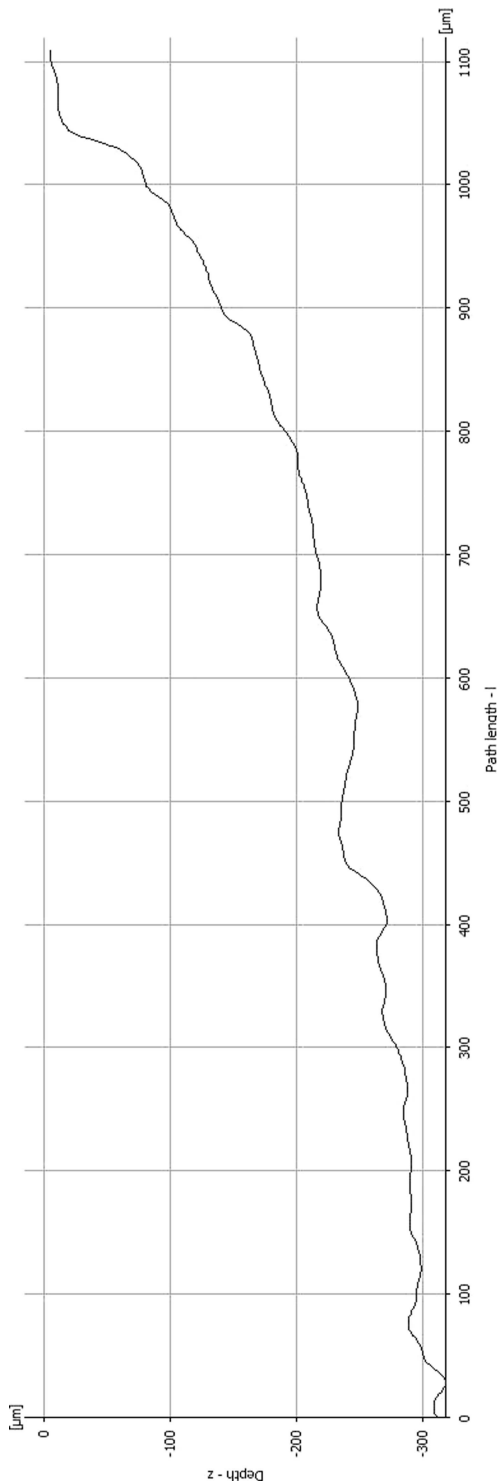
**FIGURE 18.16** Depth profile measurement of the deepest pit in the sample from the Knowledge Center.

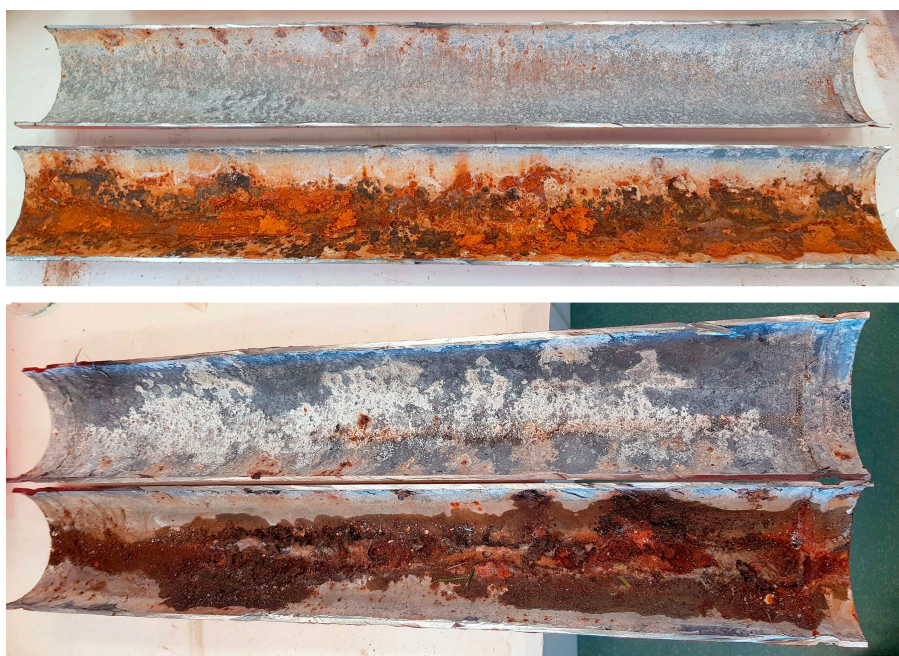
**FIGURE 19.2** Pipe 1 (up) and pipe 2 (down). For both pipes, the 12 o'clock position with white precipitation is placed on top and the 6 o'clock position with rusty-brown precipitations is shown below.

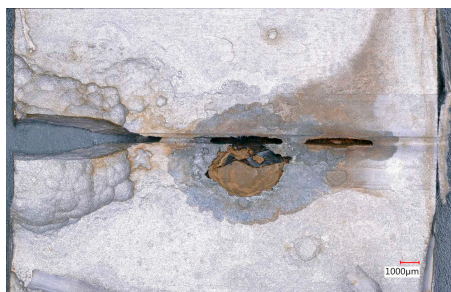
For further investigation of the morphology of corrosion damage at the surface of the pipe walls, the samples were cleaned chemically to remove all corrosion products and subsequently observed under a 3D microscope. In Figure 19.3, a clear line can be seen where pits seem to develop preferentially; this clear line is the longitudinal weld of the pipe. Preferential corrosion of the longitudinal weld is a well-known and often-occurring phenomenon (Lee et al., 2005).

**FIGURE 19.3** Example of damage on longitudinal weld of the pipe.

Looking at pit locations and morphology, it is clear that pitting corrosion may occur throughout the pipes but there is a clear tendency for pits to develop around the longitudinal welds.

The welds created are sensitive for pitting corrosion.

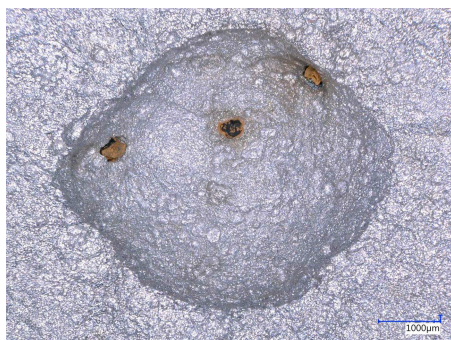
Figure 19.4 shows a detailed picture of a severe pit in pipe 2. Pit depth measured here reached 1.5 mm. With an original wall thickness of 3 mm, this means that the residual wall thickness is approximately 1.5 mm.

**FIGURE 19.4** Severe corrosion pit in the wall of pipe 1. Pit depth is 1.5 mm.

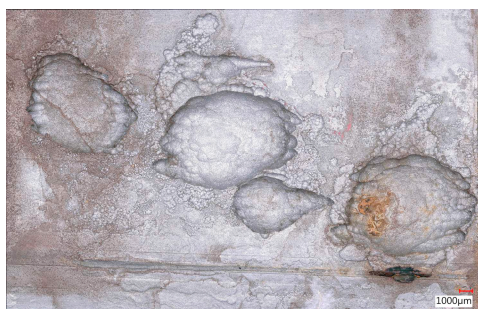
Figure 19.5 (left image) shows a picture with multiple pits observed on pipe sample 2. The maximum pit depth found here was 2.2 mm, which means that this part of the pipe had a residual wall thickness of only 0.8 mm. Actually both pipes suffered from severe pitting corrosion, so both had a low residual wall thickness. Moreover, again at the longitudinal weld a perforation was found (see Figure 19.5, right picture). The cross-cut picture clearly shows how the pit surrounds the perforation of the pipe.

**FIGURE 19.5** Example of pitting damage on pipe 2. Left: Multiple pits with max. pit depth of 2.2 mm (bottom right in this picture). Right: Detail of cross cut at perforation at the junction point.

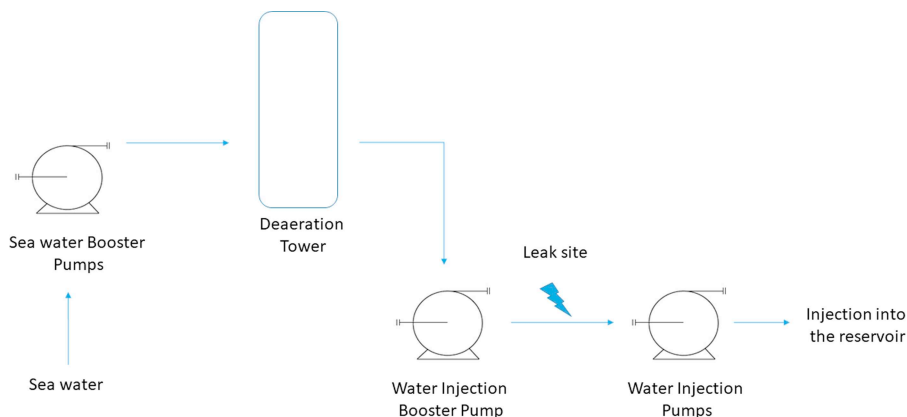
**FIGURE 24.1** Location of the leak in the offshore process system.

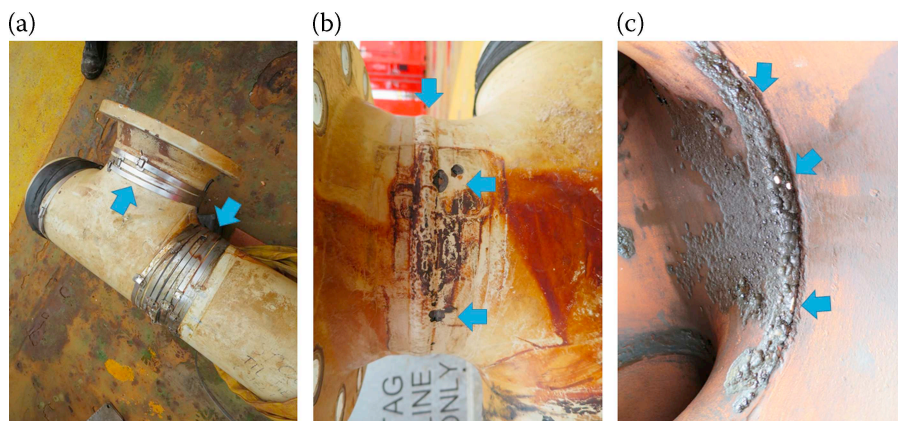
**FIGURE 24.2** Two clamps were covering the leak sites (A). Two deep penetrating pits were visible from the outside close to the weld (B). Internal view of the pipe showing the two deep penetrating pits and additional corrosion close to the weld (C). The nominal pipe dimension is 8" (219.1 mm), and the wall thickness is 8.18 mm.

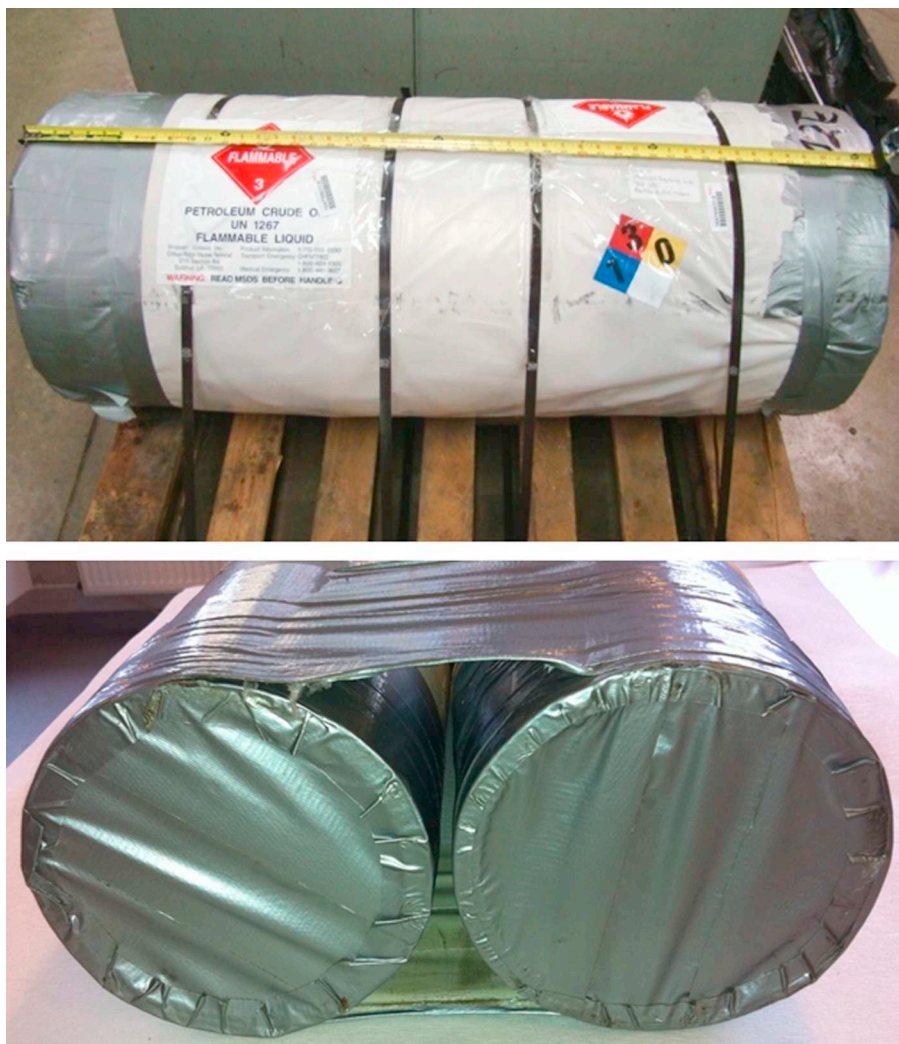
**FIGURE 24.6** Examples of how the pipe sections are sealed (individually) with clean plastic and duct tape at the ends. Pipe sections should be placed on pallets and strapped firmly before shipment.

1. Seal the pipe sections (individually) with clean plastic sheeting at both ends and seal with duct tape (see Figure 24.6).
2. Place the pipe sections on pallets and strap them firmly (see Figure 24.6).
3. Make sure the pipe sections are marked correctly on the outside.
4. Notify the onshore sampling specialist as soon as the samples leave the platform and provide the anticipated arrival time at the shore base.

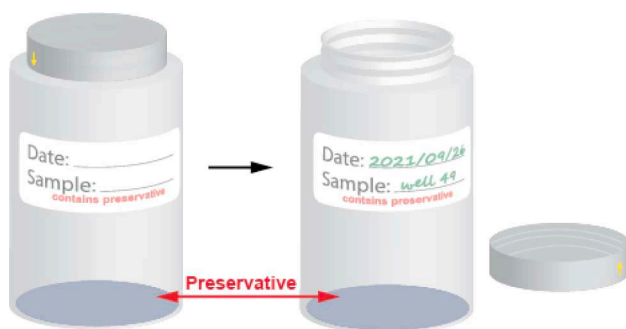
2. Label each bottle with the sampling location, date (and other relevant information if known, such as temperature, pH, etc.).
3. Unscrew the sample bottle, taking care not to touch the brim of the sample bottle or the inside of the lid; set lid down in an inverted manner on a flat surface.
4. Fill each bottle to the brim (so that it contains no air/headspace), and close the lid, taking care not to touch the inside of the lid. Seal the cap using the tape provided.

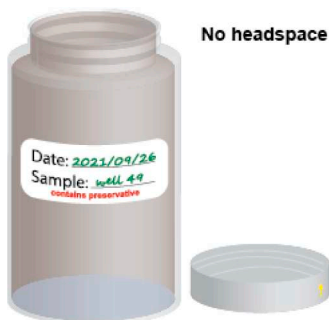
5. For bottle containing preservative, invert the sampling bottle to gently mix.
- Note:** Oil can cause tape to come off and permanent marker writing to blur, so be sure to write ID information in two different locations, such as on the side of the bottle and on the lid.

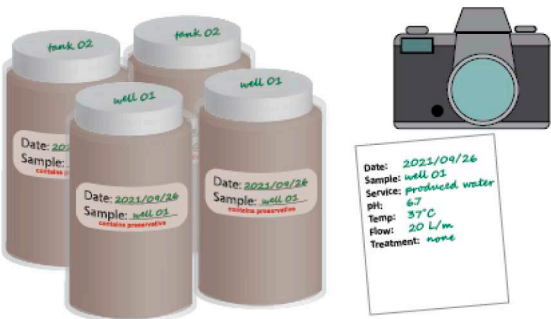
7. Take a digital photograph of the filled sample containers and your field notes.

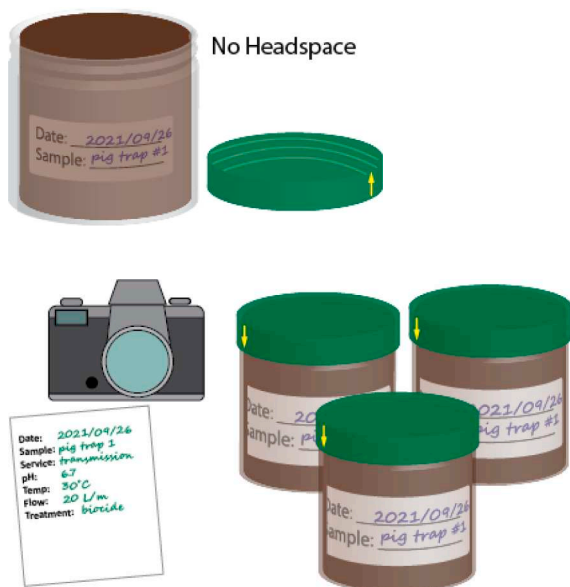
6. Clearly label the bottle on the side and lid with sampling location, pig number (1, 2, etc.), and date.
7. Take a digital photograph of the sample container (after filling) along with your field notes.
8. Place used spoons in individual plastic zip-sealed bags (labeled) and return to the lab with samples.
9. Place samples in a cooler with ice packs for shipping, tape up the cooler, and ship to the appropriate lab as soon as possible in order to maintain sample integrity.

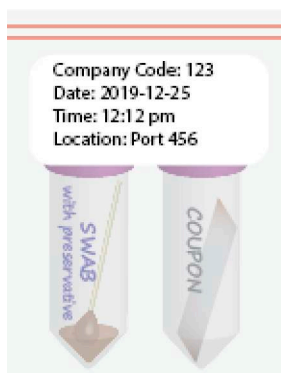
11. Place duplicate conical tubes back in the zip-sealed bag, then clearly label the bag with sampling location, data, and time of collection.
12. Place samples in a cooler with ice packs for shipping, tape up the cooler, and ship to the appropriate lab as soon as possible in order to maintain sample integrity.

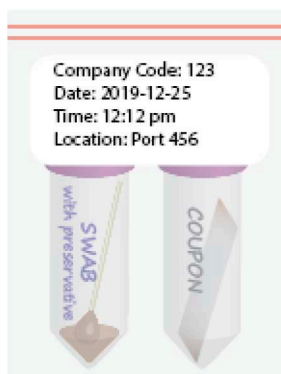
11. Place duplicate conical tubes back in the zip-sealed bag, then clearly label the bag with sampling location, data, and time of collection.
12. Place samples in a cooler with ice packs for shipping, tape up the cooler, and ship to the appropriate lab as soon as possible in order to maintain sample integrity.
